**Mack Model** LR , TE - TerraPro , AN - Anthem , GR - Granite , PI - Pinnacle

**Volvo Model** VNL , VNR , VNX , VAH , VHD

Engine family 11L Engine , 13L Engine , MP7 , MP8

**Title** Assembled Camshaft - Injector Lobe Rotation Inspection; Diagnostic Trouble Codes (DTC) P0257-00, P2A17-00, Or P2A1F-00, Possible Lack Of Power – **US17+OBD16 and Newer Emissions**

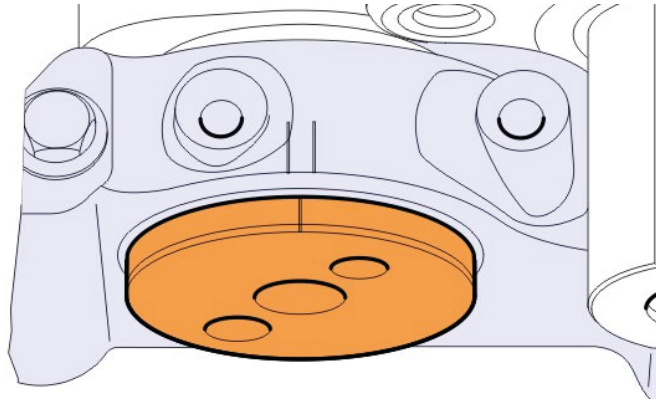
**Cause** Vehicles equipped with an assembled camshaft may present with DTCs P0257-00, P2A17-00, P2A1F-00 logging, and a possible report of instances of low power.

It is possible that these conditions are created by a cam lobe that has rotated on the camshaft itself.

1. Rotate the engine with the turning tool in the normal direction of rotation until the timing marks are aligned for the Injector Pump(s). While the engine is being rotated, confirm each injector lobe is rotating with the camshaft and does not slip.

**Solution** **An eService case should be opened with a detailed description of the findings from the inspection steps below.**

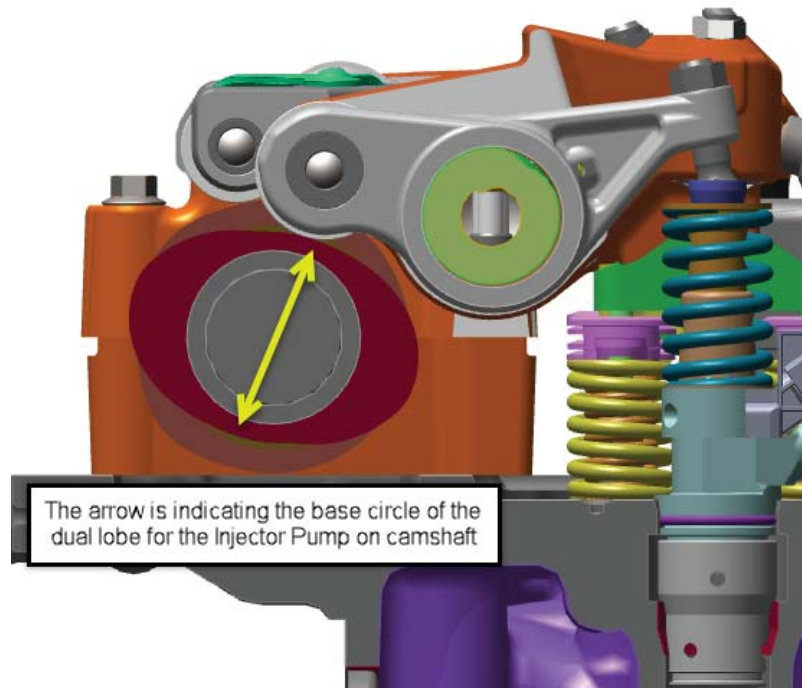
2. Once the timing marks are aligned for a specific Injector Pump, verify the injector rocker roller is on the base circle of the injector lobe. Refer to the illustration below.

**Note:** If an injector lobe rotates on the camshaft, the rotation is normally by 60 degrees. It takes approximately 15 degrees of rotation before potentially causing the faults codes listed previously or a fault for a pumping injector during the Common Rail Fuel System Test.
