Mack Model LEU , LR , MRU - TerraPro , CHU - Pinnacle, Axle back , CXU - Pinnacle, Axle front , GU - Granite , TD - Titan

Volvo Model VNL , VNM , VNX , VAH , VHD

Title ** Tech Tip ** TT - 007 - 2015 - Diagnosing The Aftertreatment Control Module DTCs P202D, P208E, P20E8 - OBD13 (Commonly Model Year 2014); Newer Chassis AFTER Reviewing Other Solutions

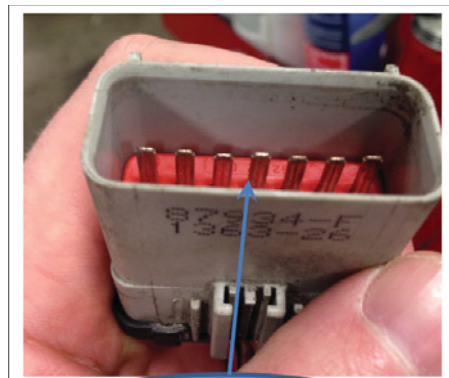
First inspection-the connector looks OK

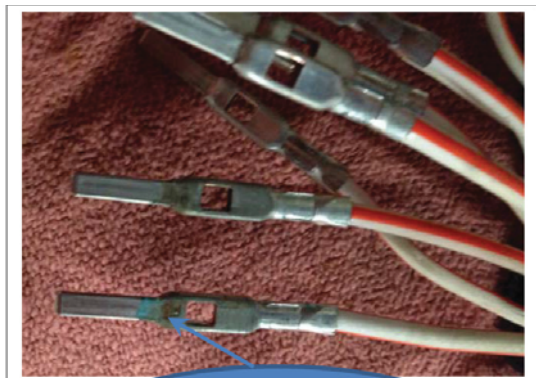
- 1. Inspect the electrical circuit connections between the ACM and the DEF pump at the DEF pump connector, ACM connector, and FCUT connector. Pay special attention to the FCUT connector. A minor amount of oxidation or corrosion will cause these DTCs.**

After removing the red retainer, corrosion is seen present in the connector.

If any corrosion is found in the FCUT connector, replace terminals on the front chassis harness and urea tank harness as required.

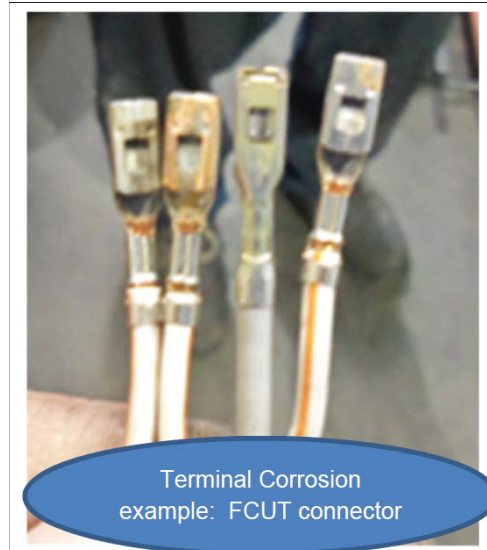
3. If the above actions do not resolve the complaint, proceed with the applicable Guided Diagnostics. Terminal Corrosion example: FCUT connector Debris found in DEF pump connector screens

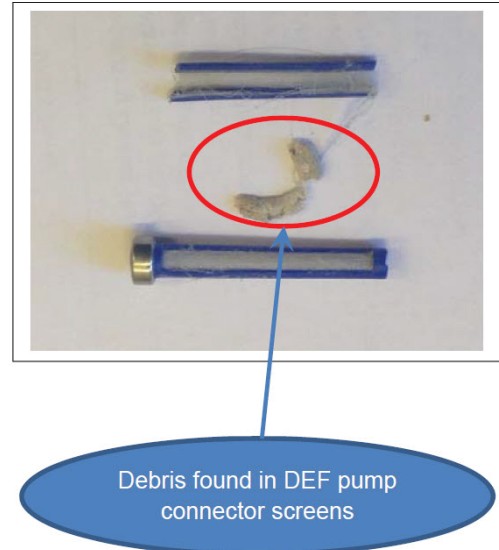
2. Inspect DEF system for contamination and clean as required. Debris can build up in the filter screens under normal operation and remain trapped in the system due to the reversion cycle at key off.

Remove the Inlet and backflow connectors and inspect the filter screens for debris and replace as required. Reference Impact 2589-11-02-05 Aftertreatment Diesel Exhaust Fluid (DEF) Contamination Flush
