Mack Models

Solution K52765591 Tuesday, March 5, 2019 5:06:25 PM CET

Mack Model	LEU, LR, MRU - TerraPro, TE - TerraPro, AN - Anthem, CHU - Pinnacle, Axle back, CXU - Pinnacle, Axle front, GR - Granite, GU - Granite, PI - Pinnacle, TD - Titan
Volvo Models	
Volvo Model	VNL, VNM, VNR, VNX, VAH
** SOLUTION **	
Title	Fault Code SPN 1056 FMI 2, Bendix Blink (Flash) Code 20-12 Trailer PMV Hold Function; ABS And TCS Lights Illuminated
Cause	A vehicle may present with ABS and TCS lights illuminated and SPN 1056 FMI 2 logged on a DTC Readout. Bendix Blink Code 20-12 will accompany this fault.
	It has been found that this condition can be caused by two reversed air lines at the trailer ABS module.
Solution Diagno	osis

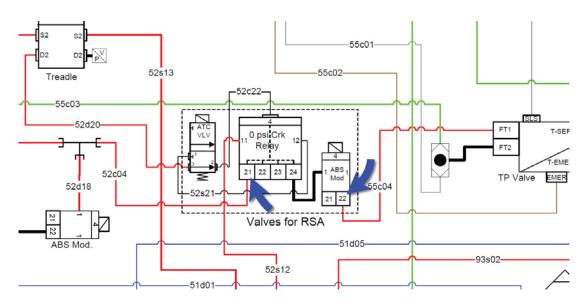
With a gauge connected inline at port FT1 of the TPV, full air pressure and a flutter between the TPV deactivation and Trailer PMV activation will be observed. On a proper functioning unit, about 35psi of steady air pressure was recorded (no flutter).

The TPV air line should be coming from port 22 of the ABS trailer module as shown in the diagram below. It was found to be routed to port 21 on units with this symptom. The blue arrows show the two ports that may be reversed.

In the cases described above, the TPV air line was found to be connected to port 21.

Swap the air lines between ports 21 and 22. Recheck the function.		
Internal comments (BO)	Refer to SR # 1-8821303991 for more details.	
Solution visibility	Dealer distribution	
Function(s)/compone	ent(s) affected	
Function affected	braking/auxiliary pneumatic circuits	
Function Group		
Function Group	5 brake	
Customer effect		
Main customer effect	fault code/display	
Fault code(s)		
US10 Fault Codes	SPN 1056 FMI 2	
Administration		
Author	RU3011V	
Dealer ID	RU4469V	
Last modified by	RU4469V	
Creation date	02-10-2018 17:10	
Date of last update	14-02-2019 18:02	
Status	Published
