Subject: Detroit DT12 Split Rod Bushing Repair

SUBJECT: **Detroit™ DT12™ Split Rod Bushing Repair**

Note: This document supersedes Technical Service Letter 16 TS-22.

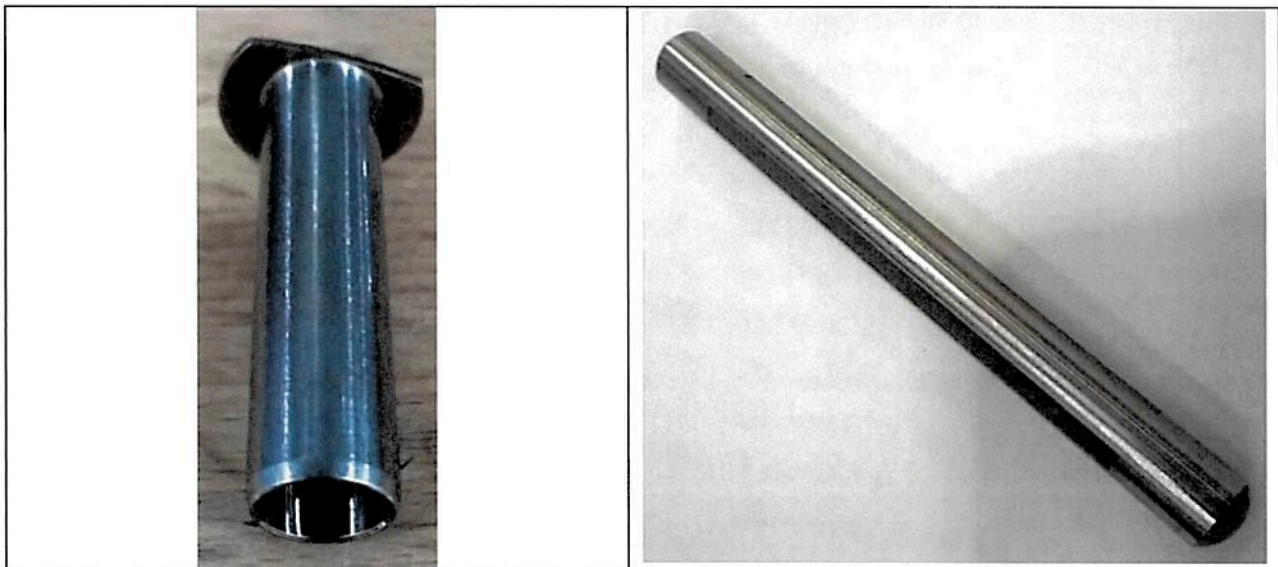
Detroit™ DT12™ automated manual transmissions may experience difficulty going into gear, especially when the transmission is not at operating temperature.

The steel split rod wears on the aluminum transmission housing, causing the split rod to stick. The Shift Controller cannot read the correct position of the split rod and will not shift into gear. To correct this, a hardened steel bushing and new design split rod with three flattened sides were implemented with transmissions built in August, 2016. For Detroit-built transmissions (transmission serial number beginning with 716), the change took place on August 9, 2016, with approximate transmission serial number 716310E0008107. For German-built transmissions (transmission serial number beginning with 715), the change took place on August 29, 2016, with approximate transmission serial number (last seven digits) 1806530. See Figure 1 for the new bushing and split rod.

Figure 1 – New Steel Bushing and Split Rod

The necessary parts to install the new bushing and split rod are contained in service kit P/N: A 960 268 23 74. The new kit is also shown in PartsPro in design group 342.

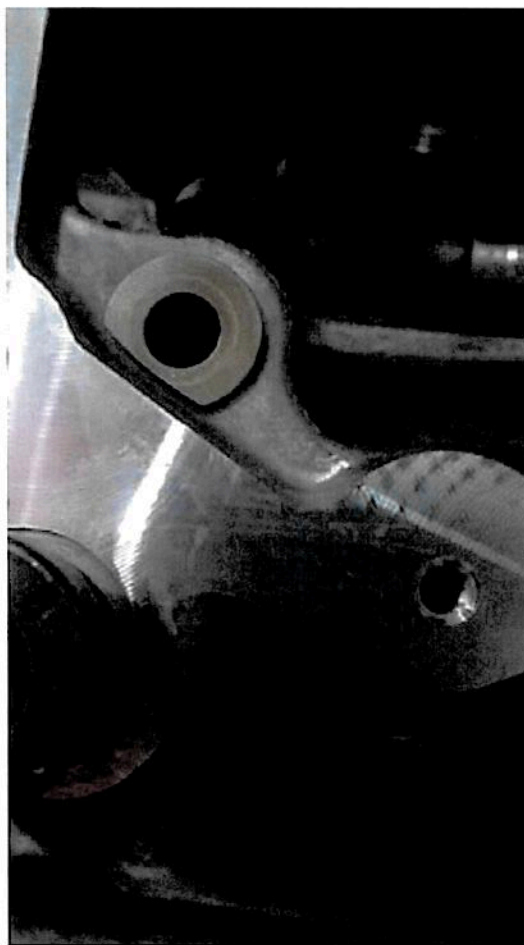
Figure 2 – New Steel Bushing Installed

In the *Detroit Transmissions Manual* (DDC-SVC-MAN-0140), reference the chapter titled “Internal Component Repair” and section “Split Rod Bushing Repair”. A supplemental video can be found on ddcsn.com. Go to Support, then Multimedia, then DT12 Transmission, then Split Pin Bushing Repair. See Figure 2 for the new bushing installed in a transmission. Note how the cut side of the bushing matches up with the transmission housing.
