PIP5598A Diagnostic Tip: Possible Crank No Start Or Extended Crank No Codes

Involved Region or Country:	North America
Condition:	Possible Crank No start or Extended Crank No Codes
Cause:	Possible exhaust camshaft reluctor out of phase

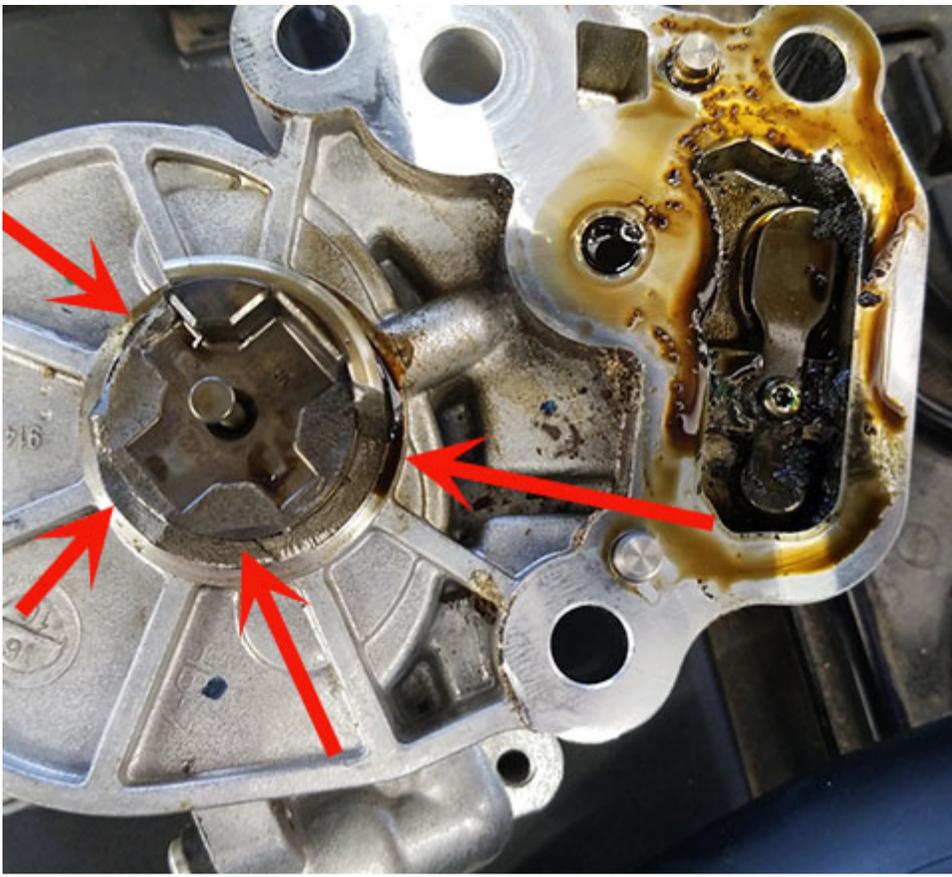
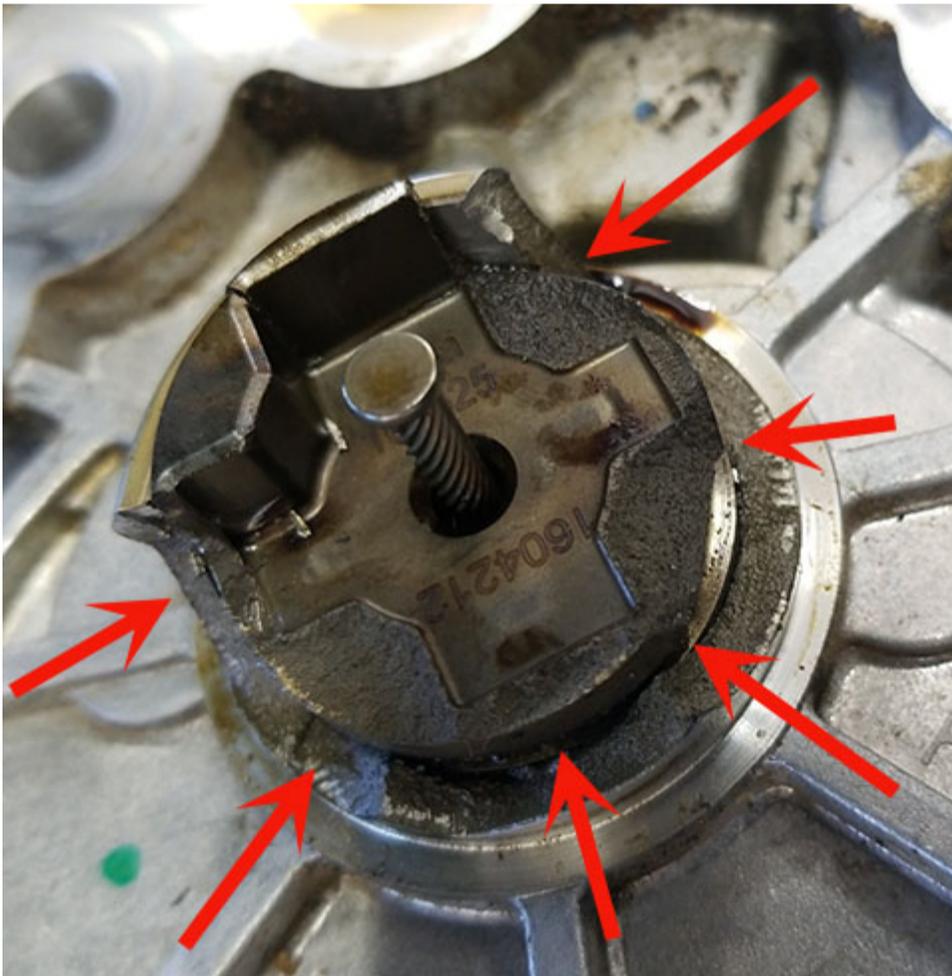
Remove cam cover assembly and perform steps below to confirm exhaust camshaft reluctor orientation. During disassembly the vacuum pump drive lugs should also be inspected for damage. (Photo below show damaged vacuum pump drive lugs)

If you find the vacuum pump drive lugs are broke and/or the exhaust camshaft retractor is out of position then replacement of the exhaust camshaft and vacuum pump will be required.

Note: If needed, It will also be necessary to locate and remove the broken vacuum pump drive lugs and other metal debris during repairs.

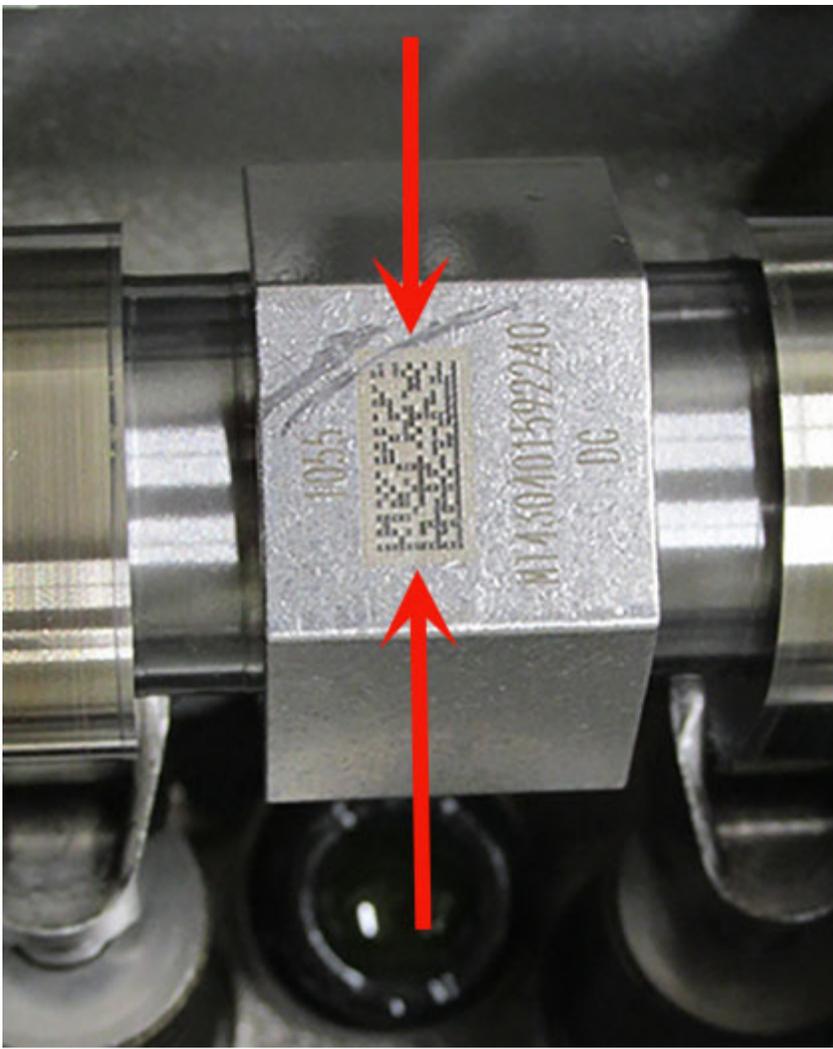
Rotate the exhaust camshaft to position the 2D matrix marking on the camshaft hex in the 12"o'clock position.
(Reference photo below for 2D marking.)

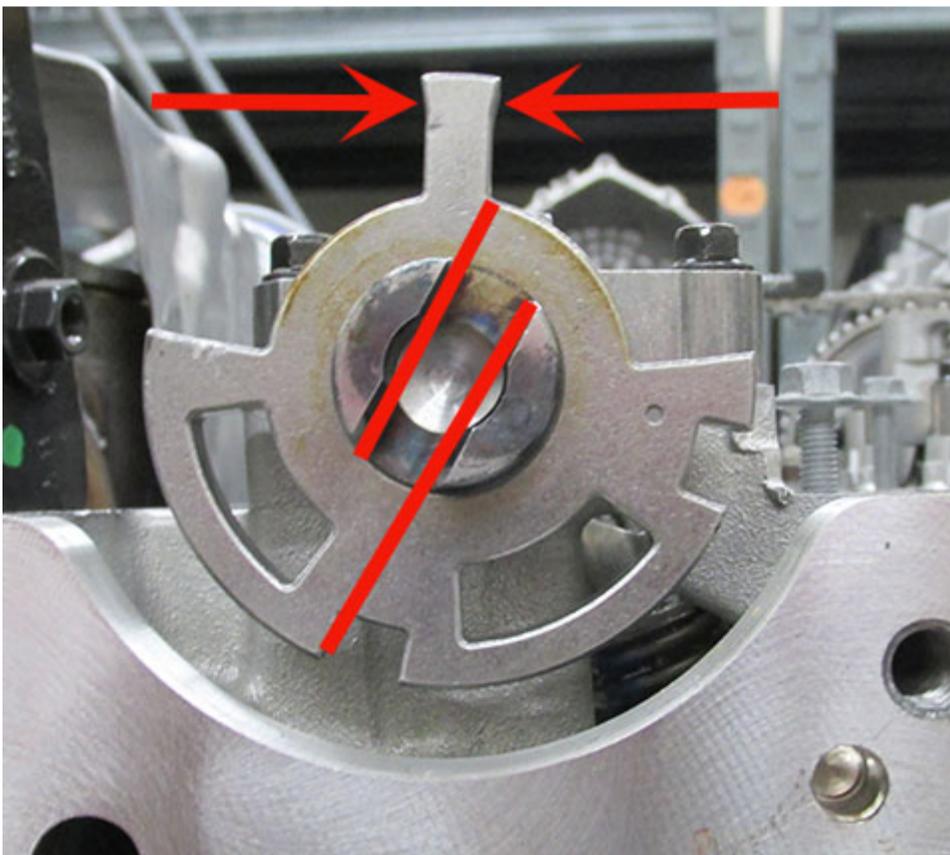
Once the exhaust camshaft 2D matrix has been positioned at 12"O'clock. Verify the small tang located on the camshaft reluctor ring (Arrows below showing tang on reluctor) is inline with the 2D matrix marking. Also shown are additional reference points used to verify exhaust cam reluctor orientation to camshaft.

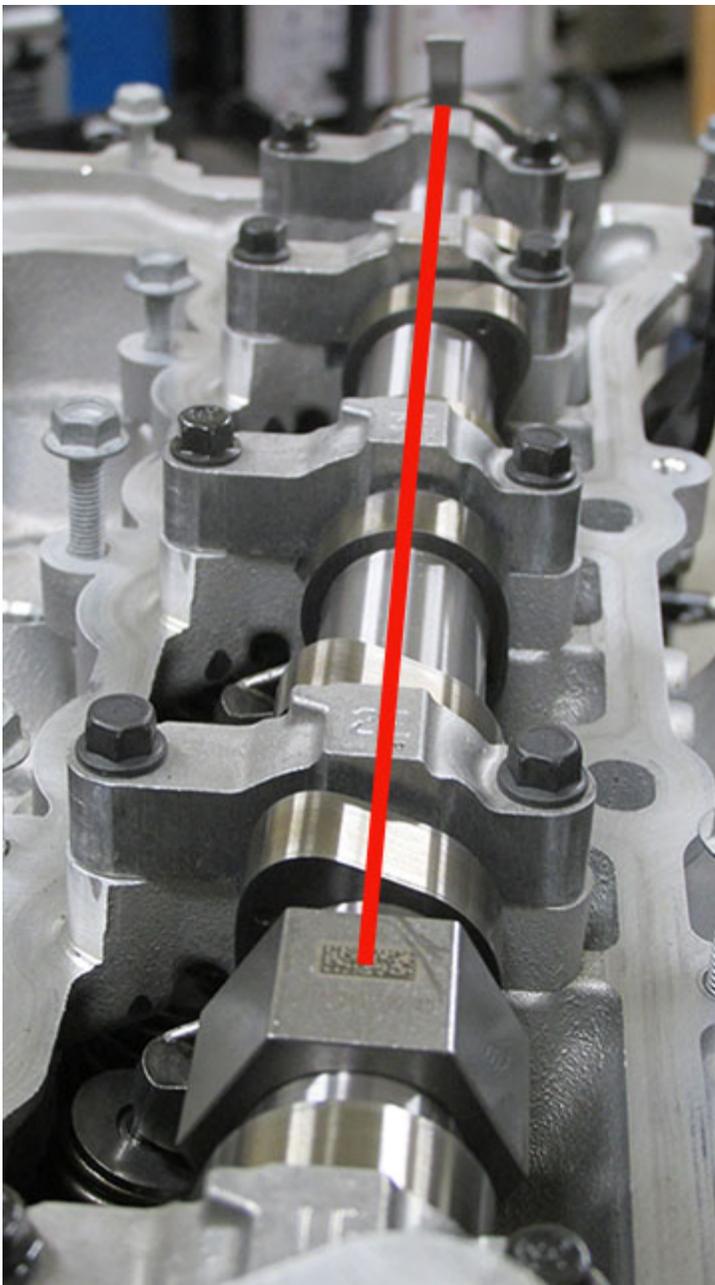
Photo below is showing the proper relationship between the 2D matrix marking and the small tang on exhaust cam reluctor wheel.
