Technical Service Bulletin

SUBJECT:		No:	TSB-19-54-002
FUEL REMAINING DISPLAY INCORRECT AFTER FILLING TANK		DATE:	February 2019
		MODEL:	2018-2019 Eclipse Cross
CIRCULATE TO:	<input type="checkbox"/> GENERAL MANAGER	<input checked="" type="checkbox"/> PARTS MANAGER	<input checked="" type="checkbox"/> TECHNICIAN
<input checked="" type="checkbox"/> SERVICE ADVISOR	<input checked="" type="checkbox"/> SERVICE MANAGER	<input checked="" type="checkbox"/> WARRANTY PROCESSOR	<input type="checkbox"/> SALES MANAGER

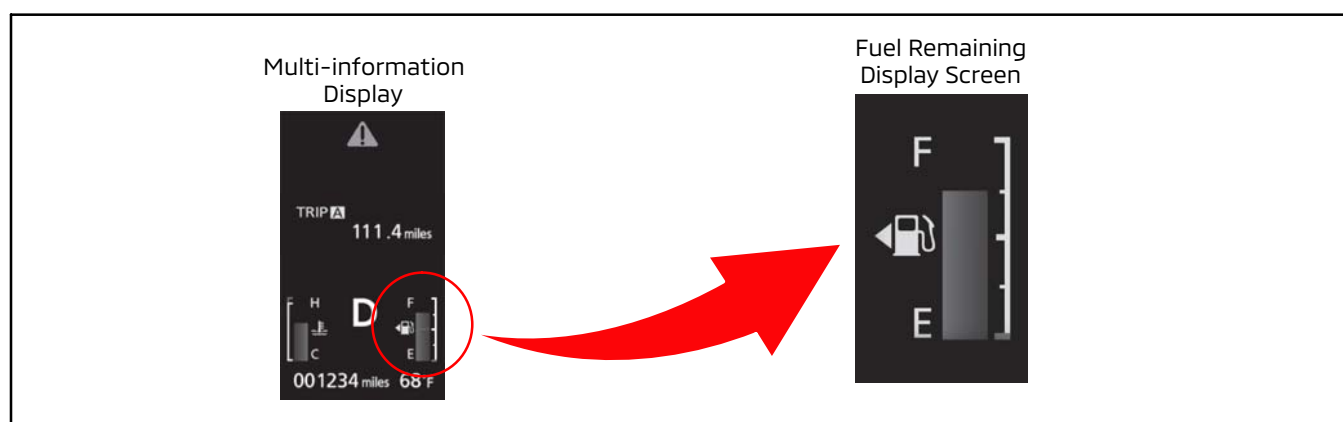
When the vehicle is stopped on a slope, the fuel remaining display in the Multi-information display may not show a full level even when the fuel tank is full. At the same time, illumination of other displays function properly, including the low fuel level warning.

This TSB instructs dealers to reprogram the Combination Meter with updated software to correct the fuel remaining display issue.
