SERVICE BULLETIN

Classification: BT18-003a	Reference: NTB18-032a	Date: February 19, 2019
------------------------------	--------------------------	----------------------------

ALTIMA AND MAXIMA; NOISE FROM TRUNK AREA

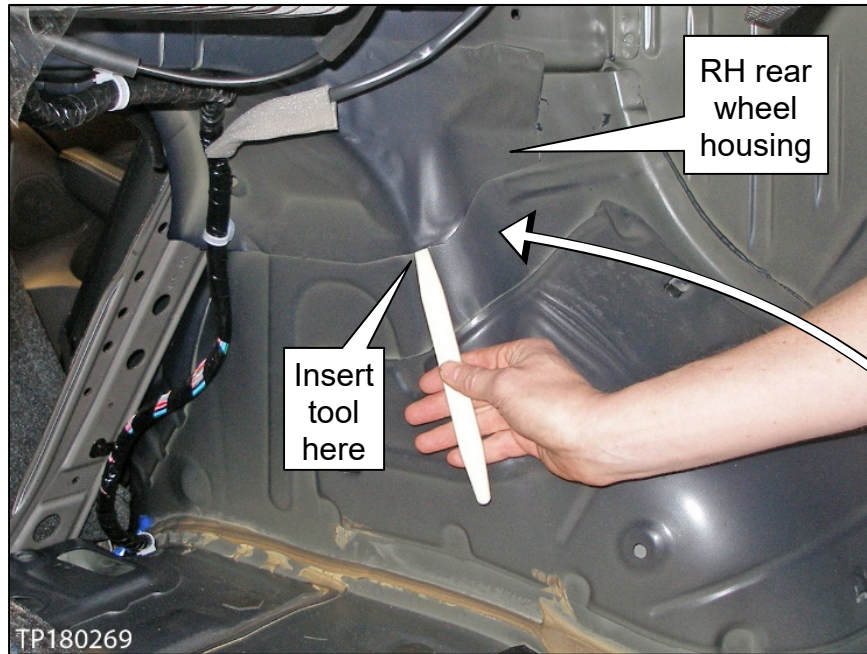
Figure 7

A ticking, tapping, or popping type of noise is coming from the area of the right rear parcel shelf or right rear passenger seatback area while driving.

8. Insert a plastic interior pry tool where shown in Figures 7 and 8, and then carefully widen the gap between the two body panels about 3/32 inch (3 mm).

- Make sure to insert the plastic interior pry tool at least 1³/₈ inches (35 mm) up into the gap, and then spread apart.

CAUTION: Do NOT use a metal pry tool. It may puncture through the body panels. Use an interior plastic pry tool similar to the one shown on the next page, below PARTS INFORMATION.
