Random Misfire Under High Load

Service Category Engine/Hybrid System

Section Engine Control

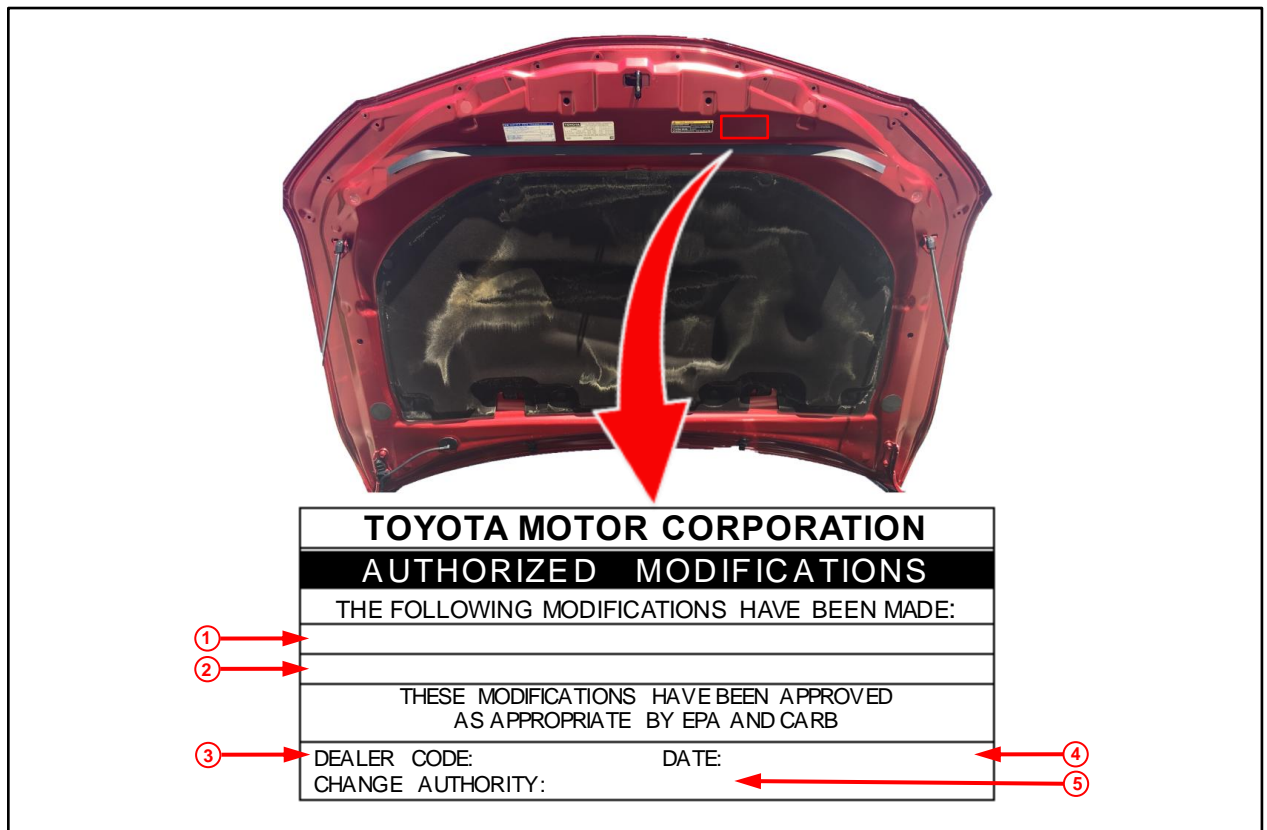
Figure 1. Location of Authorized Modifications Label on 2018 Camry and 2019 Avalon

- Check for the Authorized Modifications Label affixed to the vehicle in the locations shown below. Confirm if the ECM (PCM) calibration has been updated.

B. Install the Authorized Modifications Label onto the vehicle at the location shown in Figure 1. The Authorized Modifications Label is available through the MDC, P/N 00451-00001-LBL.
