Technical product information

Topic	Bentayga - Rattle rear cabin area - Forward / rearward adjustment bar
Market area	Bentley: worldwide (2WBE),Hongkong-Macau (5HK)
Brand	Bentley
Transaction No.	2053352/1
Level	EH
Status	Approval
Release date

Rattle from the rear passenger compartment, seat cushion area.

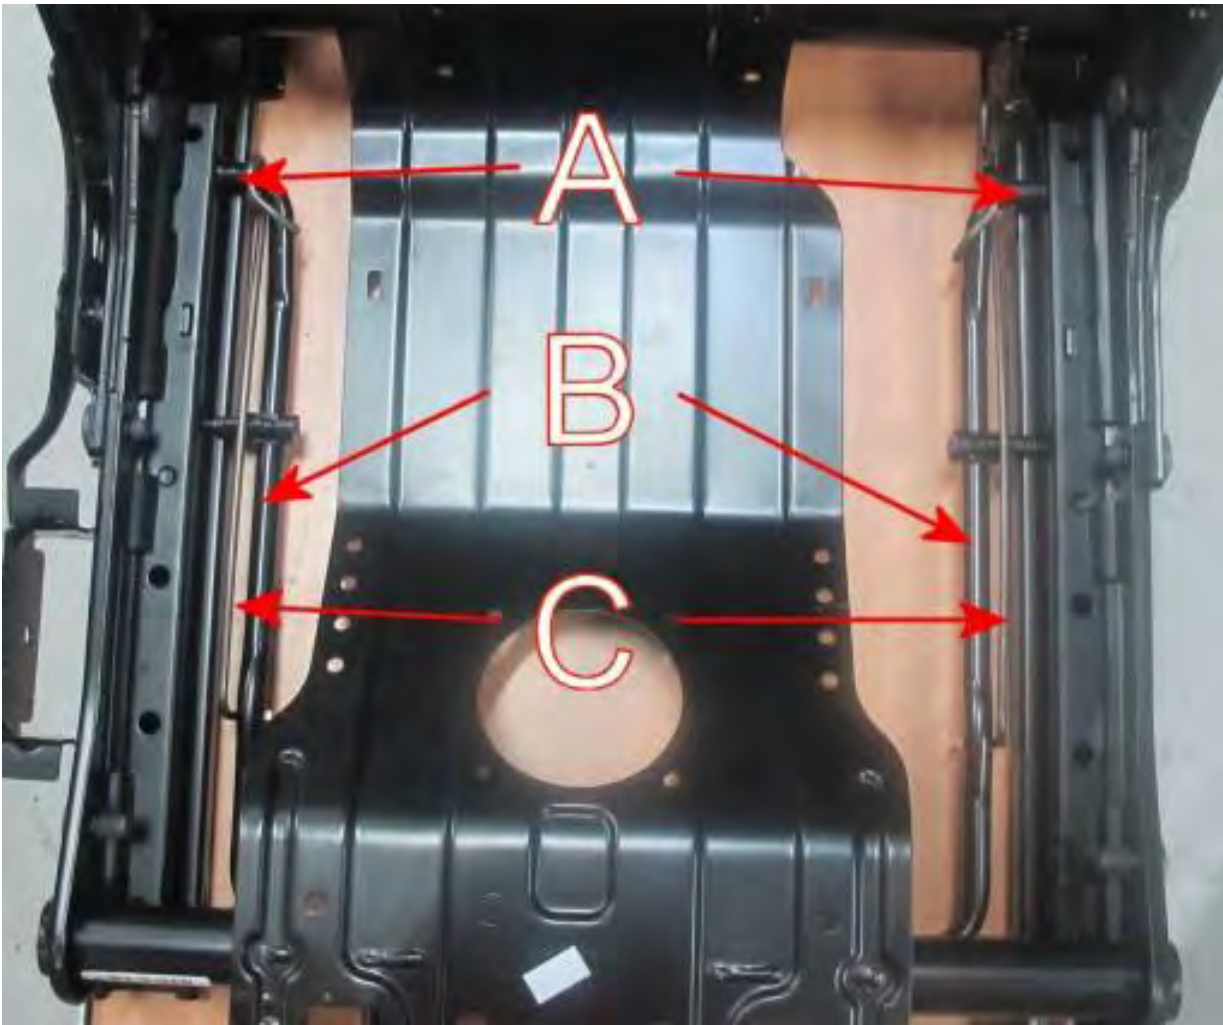
Figure 1

On Bentayga five seat vehicles, inadvertently applying excessive downwards pressure to the rear seat forwards/rearwards Adjustment Bar can damage the Pivot Bearings, once damaged the Pivot Bearings may rattle within the seat frame.

Should a rattle be present in the vicinity of the Pivot Bearings – figure 1 - continue with this TPI.

For the location of components - rear seat cushion removed – see figure 1.
