Technical product information

| Topic | Creak from behind the Drivers Information Panel/Engine compartment |

Bentayga

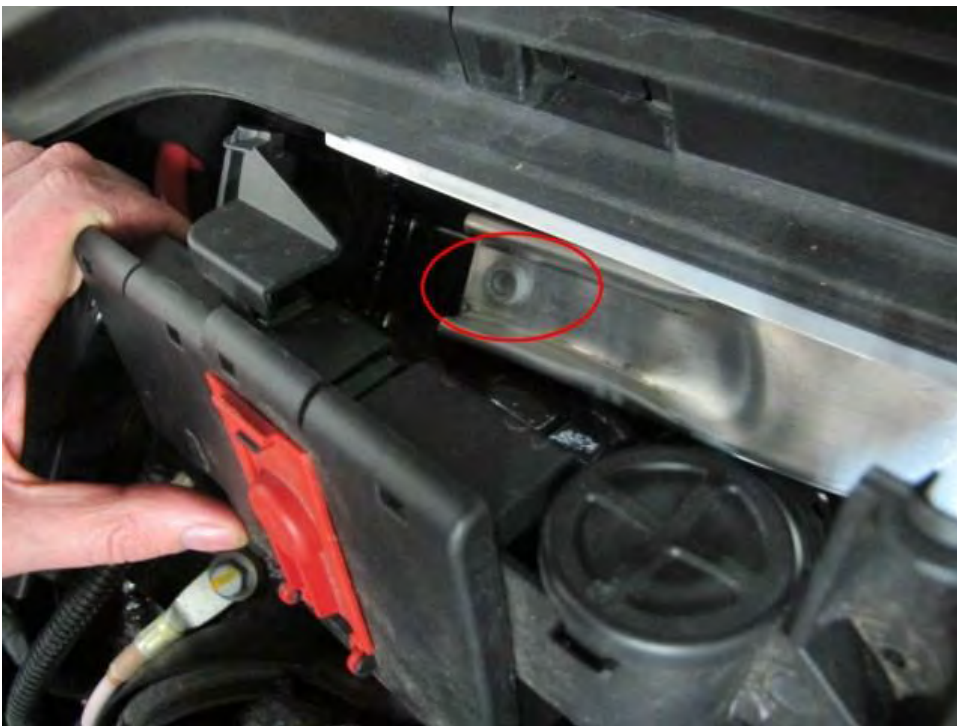
Figure 3

- Referring to Figure 3, one of the seven engine bay reinforcement fixings is shown (circled) behind the charging post

▪
Once removed take care not to damage the underbody charging post cables or surrounding components when carrying out the torque overcheck

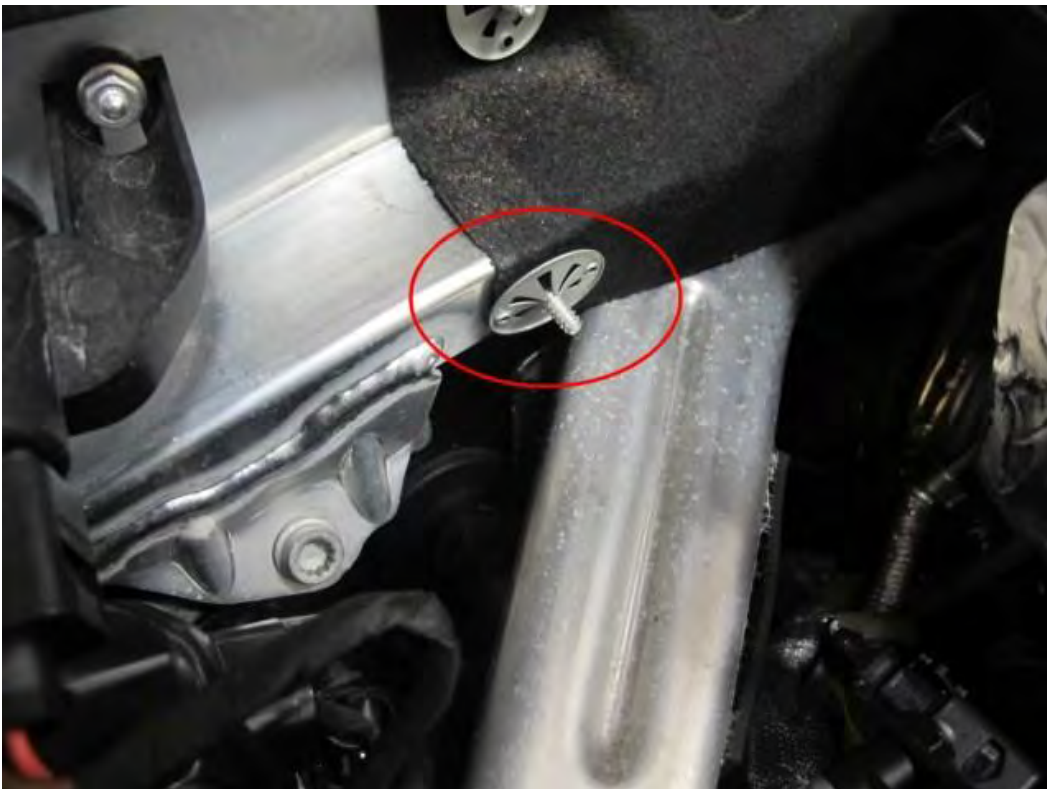
NOTE: The remaining engine bay reinforcement fixings are covered by sound proofing material

3) Remove the applicable clamping washers and discard (see Figure 5 as an example) then manoeuvre the sound proofing to allow access to the engine bay reinforcement fixings

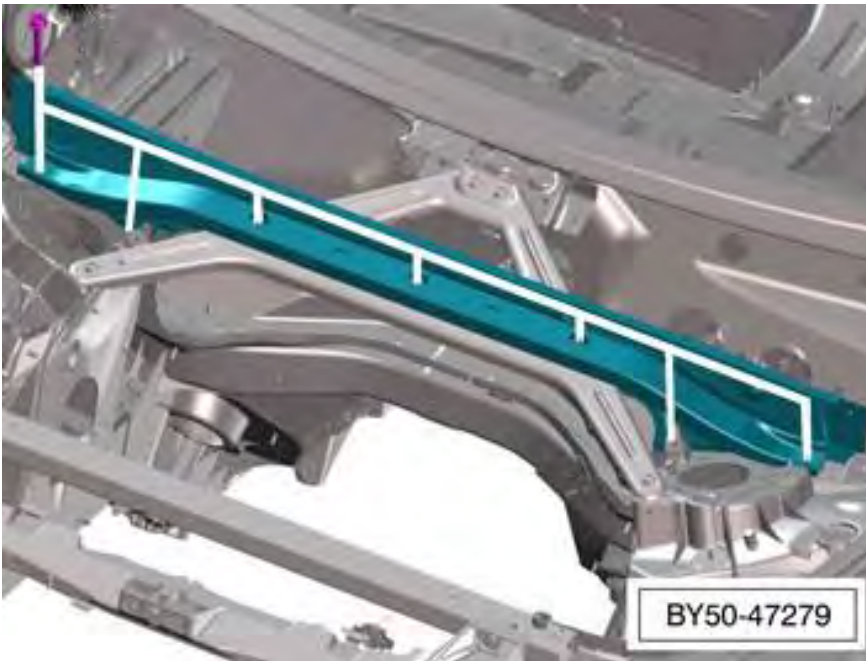
The noise within the sound file relates to a tolerance mismatch between the Engine bay reinforcement and the Torsion strut, the seven fixings which secure the engine reinforcement to the bulkhead/torsion strut require a torque over check

4) Referring to Figure 6 - Torque tighten the seven fixings shown to 25 Nm
