Service Bulletin

Bulletin No.: 18-NA-362

Subject: Wind Noise and/or Water Leak at Front Roof or Windshield, Water Running Down Interior A-Pillar

Brand:	Model:	Model Year:		VIN:		Engine:	Transmission:
		from	to	from	to		
Cadillac	ATS	2014	2019			All	All
	CTS Sedan (VIN A)	2014	2015				
	CTS	2016	2019

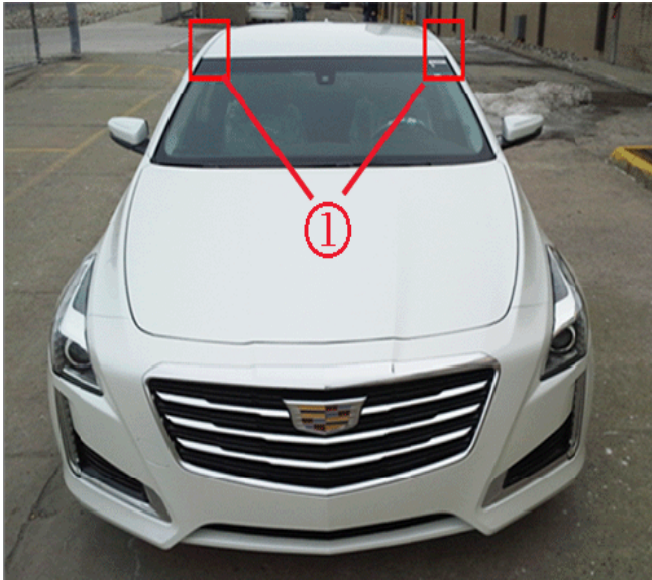
4233881

Involved Region or Country	North America and N.A. Export Regions
Condition	Some customers may comment on hearing a wind noise from the front roof/windshield area, or on finding water/wet carpet in the front floor footwell area.
Cause	<p>The cause of the condition may be pin holes, cracks or voids in the forward roof ditch laser braze area, or in the upper windshield flange seam or lower corners of the windshield opening. Examples of the leak areas are shown below.</p> <p>Possible Laser Braze Water Leak Areas (1)</p>

Following the Service Procedure below, inspect the forward laser braze and water test the roof ditch and upper windshield area on the affected side(s).

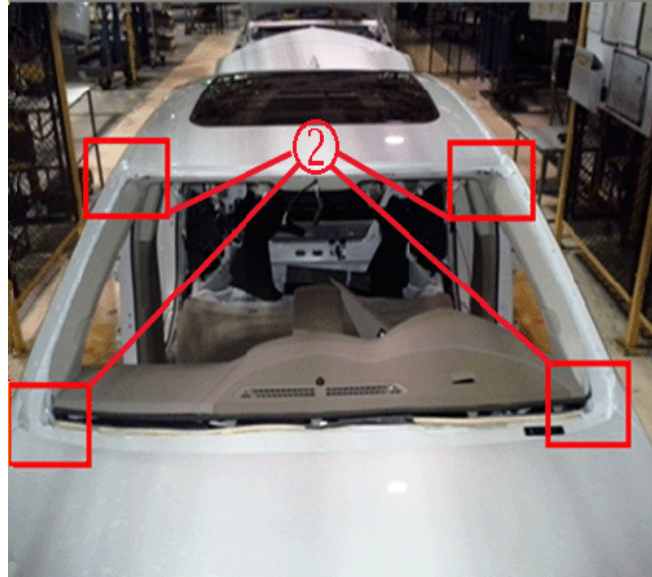
4233886

Possible Windshield Opening Flange Seam Water Leak Areas (2)

9. On the affected side(s), inspect the upper windshield flange seam (at the end of the laser braze) (1) and the lower corner flange seam (2) for any visual signs of pin holes, voids or skips. Reseal any seams, as necessary.

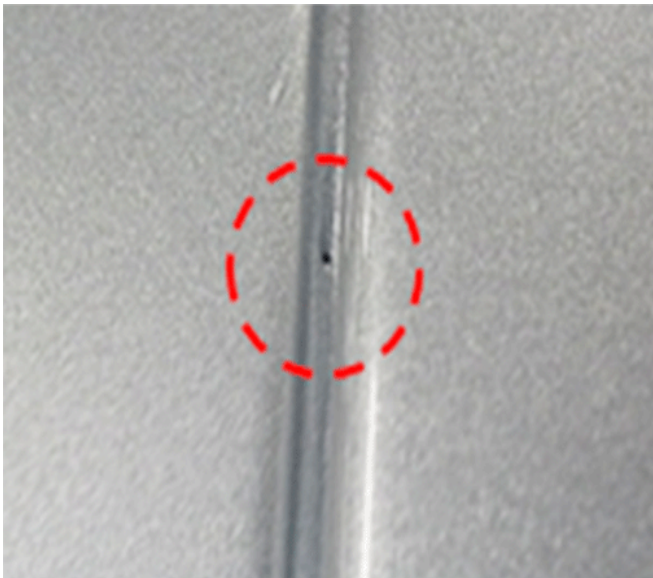
4233899

Note: The pin holes/cracks may be more difficult to see on darker color finishes. An example of a visible pin hole is shown in the graphic above.

6. Seal the holes/crack in the laser braze following the steps below:
- 6.1. Mix a small amount of *Kent Automotive High-Tech Clear Seam Sealer, P/N 10200 (5 oz tube), or equivalent, WITH the proper touch up paint color.
 - 6.2. Avoiding excess sealer build up within the ditch, work a small amount of the sealer into the hole with a gloved finger.
 - 6.3. Wipe away any excess sealer with a light amount of solvent on a rag or paper towel. The solvent will help the sealer flow into the hole/crack.

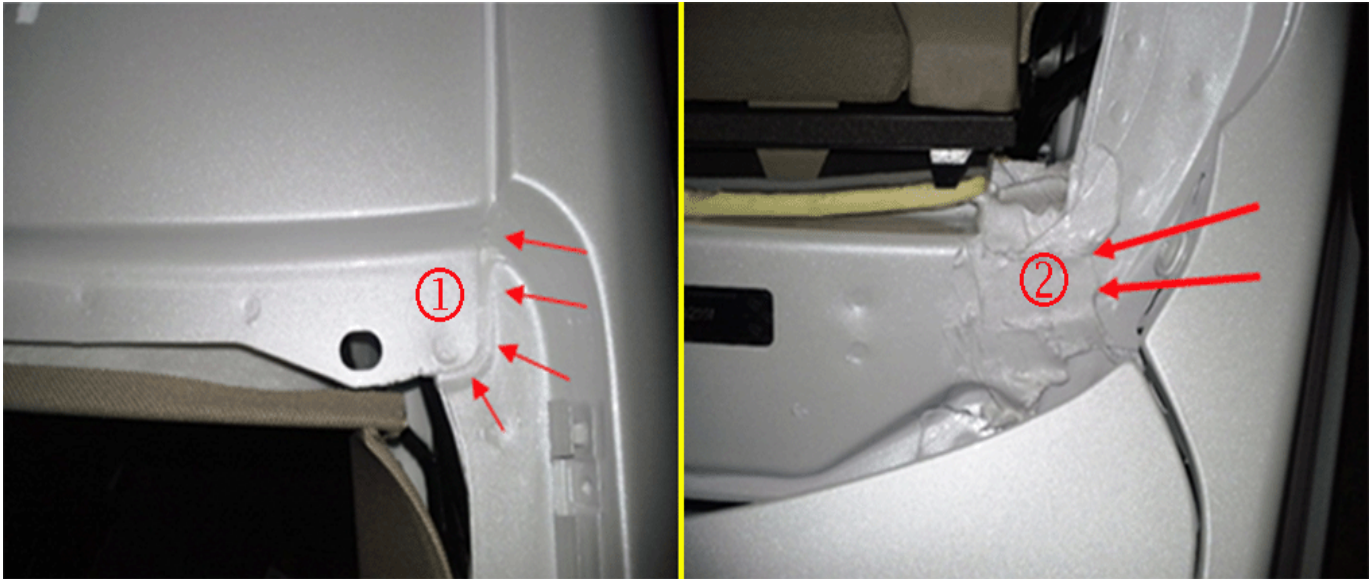
4233900

Note: The examples above are showing the left side, but condition could be on either side.
