# Service Bulletin

Bulletin No.: 18-NA-369

**Subject:** Information On Power Liftgate Assist Actuator Replacement

Brand:	Model:	Model Year:		Breakpoint:		Engine:	Transmission:
		from	to	from	to		
Cadillac	Escalade Models	2017	2018				
Chevrolet	Suburban						
	Tahoe						
GMC	Yukon Models

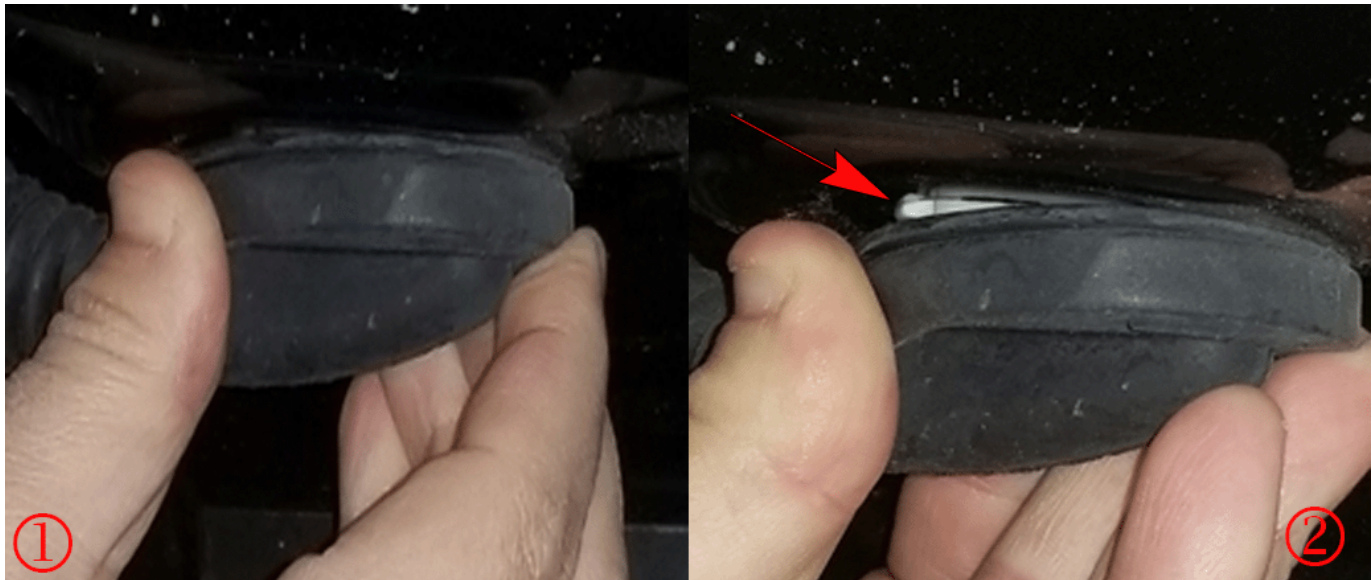
The purpose of this bulletin is to receive feedback from the dealership technician. Prior to replacing the power liftgate assist actuator, verify the liftgate actuator grommet is properly seated to the sheet metal (1) with NO gaps (2) which could result in water intrusion into the liftgate. To check retention, pull down on each of the 4 corners individually to see if the clip is secured to the sheet metal or if the grommet pulls away easily.

Visually inspect or feel the entire lip seal of the grommet to check for proper seating. Please report back any grommet issues that may have resulted in water intrusion in the causal warranty verbatim or submit a Field Product Report (FPR). For additional information on the FPR process, refer to the latest version of bulletin 02-00-89-002.
