Service Bulletin

Bulletin No.: 18-NA-335

Subject: Information on Small Engine Water Pump and Water Pump Housing Replacement

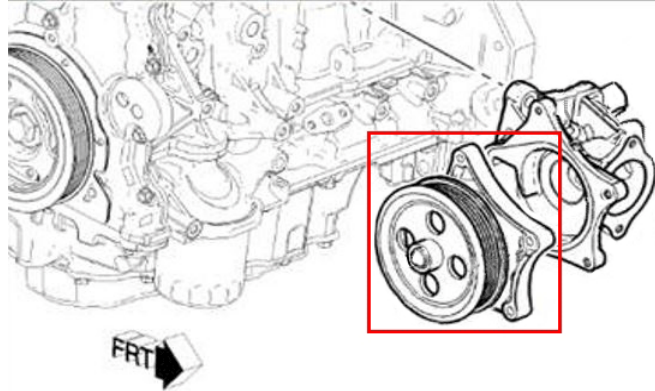
5162998

The image above depicts a **Water Pump Housing**:

- ⇒ If the water pump requires replacement for a noise, leak or poor coolant flow. Refer to *Housing w/PMP* in the EPC when ordering parts.
- ⇒ Use labor code 4032740 - Water Pump Housing Replacement.

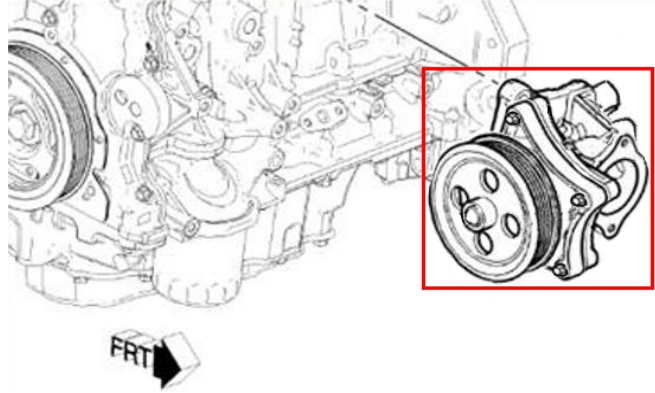
5163000

The image above depicts a **Water Pump**:

Note: When ordering the water pump. A water pump housing comes pre-installed on the water pump as an assembly.

- ⇒ If the water pump requires replacement for a crack or leak. Refer to *Pump, Wat* in the EPC when ordering parts.
- ⇒ Use labor code 4032750 - Water Pump Replacement.
