**Rear Wiper Arm Cover Falls Off**

Model	Model Year	Model Type	VIN Range	Vehicle-Specific Equipment
Cayenne	2019	9YA	N/A	N/A

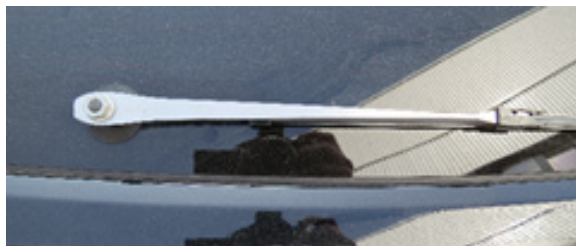
The rear wiper arm cover falls off of the vehicle.

The attachment tabs were insufficient to hold the cover on the wiper arm.

Install new wiper arm cover with part number 974.955.435.B. Do not use the previous cover with index A. PET is accurate with this information.

5	974 955 435 A	Cover cap No longer use the part here
▶ 5	974 955 435 B	Cover cap
6	974 955 427 A	wiper blade
