# SERVICE BULLETIN

Classification: EL16-015b	Reference: NTB16-028b	Date: February 4, 2019
------------------------------	--------------------------	---------------------------

## INTELLIGENT KEY BUTTONS INOPERATIVE BUT REQUEST SWITCHES WORK

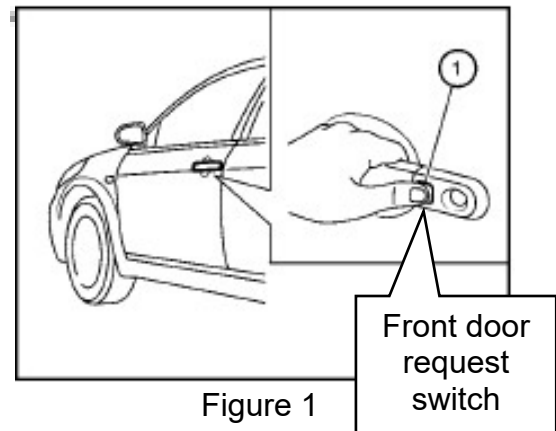
Figure 1

- If all buttons (lock / unlock / panic / trunk) on an Intelligent Key(s) do not work,

- With the Intelligent Key in range, the doors will lock and unlock when pressing either front door request switch (see Figure 1),

- That specific Intelligent Key may have become de-synchronized with the vehicle.

- Intelligent Key de-synchronization may occur if the Intelligent Key is not used for an extended period of time, or if the Intelligent Key was not operating due to low battery condition and the battery has been replaced.
- **DO NOT** replace the BCM, Intelligent Key, or any other parts if an Intelligent Key only needs to be re-synchronized.
