# **Technical Journal**

## 12V battery message and DTC CEM-B129F96

REF NO: TJ 34241.1.2	ISSUING DEPARTMENT: Technical Service	CAR MARKET: United States and Canada		
3 US 7	PARTNER: '510 Volvo Car USA	ISSUE DATE: 2018-12-20	STATUS DATE: 2018-12-20	
FUNC GROUP: 3730	FUNC DESC: Cable system, front	Page	1 of 3

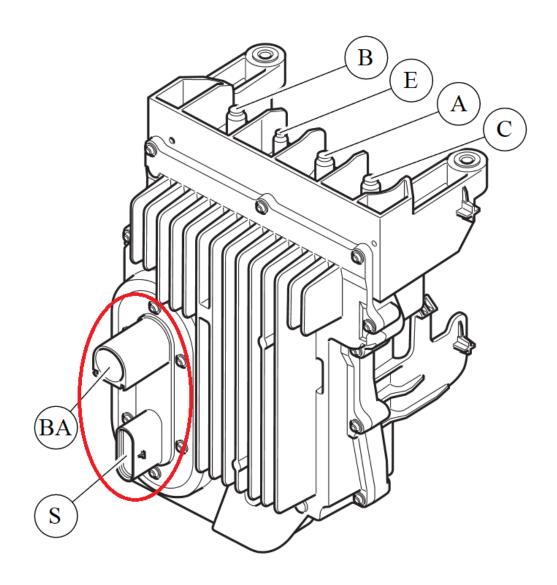
File Name	File Size
BCSM connectors TJ 34241.pdf	0.1298 MB

If DIM message "12V battery charging fault" is displayed and DTC CEM-B129F96 is permanent, please follow the instructions under "Service".

- Check that the main and secondary batteries are charged to at least 12.4 volts / 70%.
- Remove the lower connector (S) on the BCSM for 15 minutes (See attachment). This will reset the BCSM and the internal flash memory.
- Reconnect the BCSM.
- Erase all DTC's.
- Ensure stop/start functions, if the DTC does not reoccur the vehicle is OK.
- If the DTC reoccurs please follow the instructions under Vehicle Report.
