**Complaint - Battery Low and Yellow Warning Message "Battery low \_ Service necessary" in instrument cluster: Re-programming gateway control unit (battery sensor) (168/18)**

Model Line: **Cayenne (9YA)**

Model Year: **As of 2018 up to 2019**

Subject: **Gateway control unit (battery sensor)**

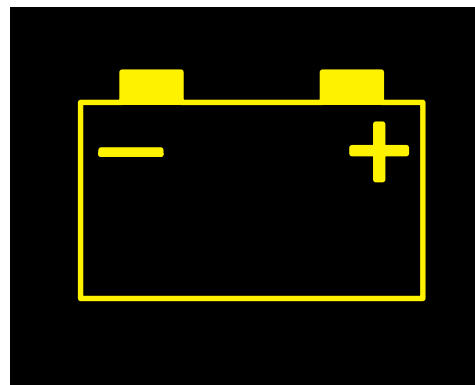
**In the event of a customer complaint** about a **flat battery** and if the yellow warning message **"Battery low \_ Service necessary"** (⇒ *Yellow warning message: Battery low \_ Service necessary*) appears in the instrument cluster, the following points must be observed before doing any other work:

- A chain of different factors can cause an increased closed-circuit current (greater than 1.0 A) after charging, see also ⇒ *Technical Information '944900 Complaint - Battery flat and specific fault code in front-end electronics control unit: Observe specified procedure (154/18)'*.
- A **battery sensor software version lower than "1000"** can bring about this symptom.
- In the event of a customer complaint and if the **battery sensor software version in the gateway control unit is lower than "1000"**, **re-program** the **gateway control unit** as described in the "Procedure" section.

*Yellow warning message: Battery low \_ Service necessary*
