# Service Information Letter

Units Affected: AT37M, AT37P, AT41M, AT41P, AT48M, and AT48P (see attached list)

## Shear Plate Bolt Inspection

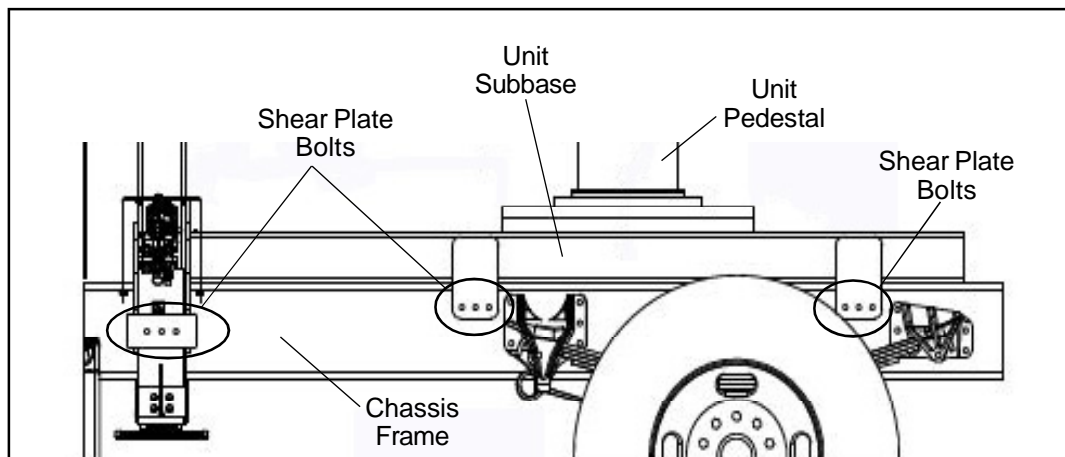
Altec has identified some fasteners that attach the unit to the chassis may not have been tightened to the proper torque value on the affected units. Incorrect torque can result in fasteners coming loose or breaking.

1. Position the unit on a level surface, apply the parking brake and chock the wheels. Engage the unit's hydraulic system. Properly set the outriggers.
2. Each of the bolts that attach the unit to the chassis (refer to Figure 1) must be checked for the proper torque value. Some chassis components may need to be loosened or removed to allow access to the bolts such as fuel tanks or DEF reservoir.

**Figure 1 — Typical Bolt Locations - Number of Bolts Differ with Models**

3. Proper torque for the bolts is 220 ft-lb. For the first part of the inspection each fastener should be checked first at 90% of the full torque or 198 ft-lb. Set the torque wrench at 198 ft-lb. and carefully check the torque of each bolt.

- If the torque wrench does not click when carefully tightening a bolt at 90%, ALL of the shear plate mounting bolts must be replaced. The inspection is complete on this unit at this time.

4. The second part of the inspection requires each fastener be checked first at 100% of the full torque or 220 ft-lb. Set the torque wrench at 220 ft-lb. and carefully tighten each bolt.

- After tightening to 220 ft-lb, the shear plate mounting bolts inspection is complete on this unit. No bolts require replacement.
5. If the shear plate bolts failed the torque inspection in Step 3, the customer can choose to replace the bolts themselves or contact Altec to do the repair. Call 1-877-GO ALTEC (1-877-462-5832) to schedule the work to be done by an Altec service technician or to order the Fastener Kit, part number 990761489, if doing the repair themselves.
