**PRODUCT CAMPAIGN BULLETIN**

**APPLICABILITY:** 2018 Model Year Legacy and Outback Vehicles      **NUMBER:** **WTW-82R**  
**SUBJECT:** Combination Meter Reprogramming      **NHTSA ID:** 18V-773  
**DATE:** 12/11/18  
**REVISED:** 02/21/19

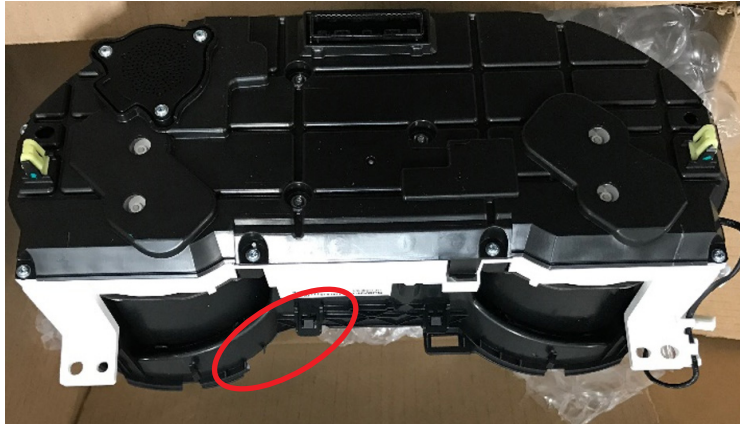
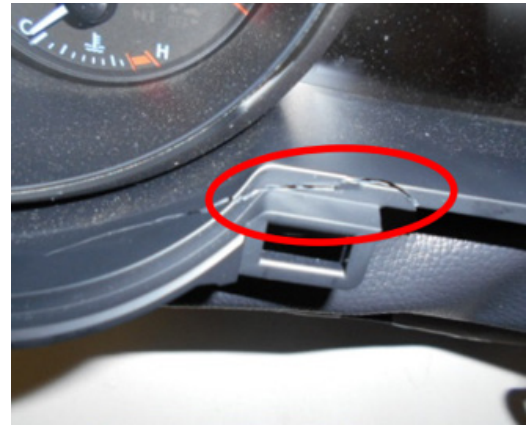
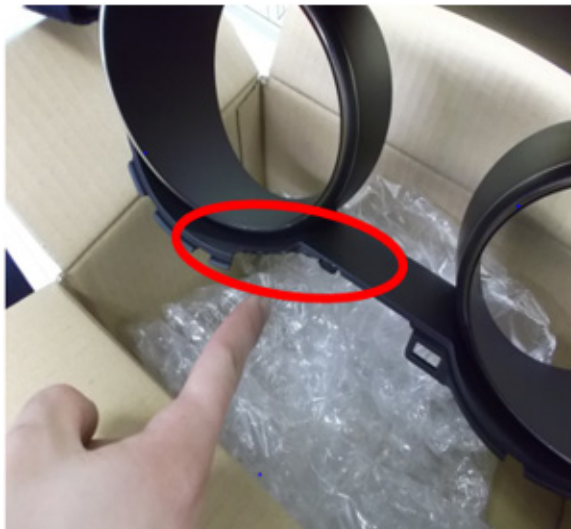
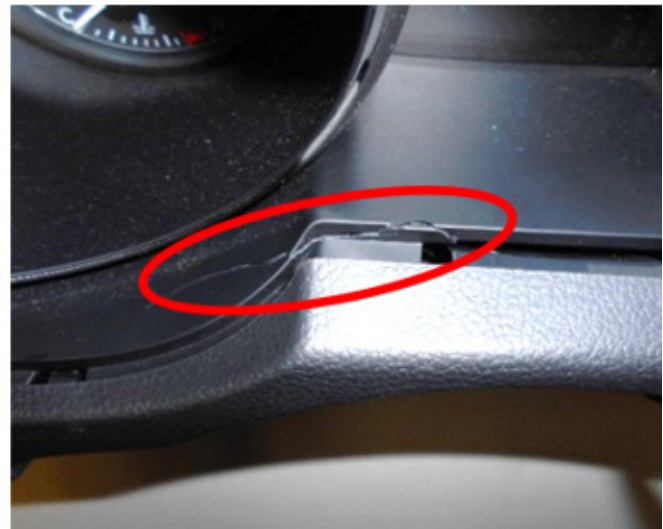
Reports of damaged meter housings as shown in the example photos below have necessitated revisions to this step.

Use the photos below for reference when **CAREFULLY** removing the combination meter lower trim bezel.

- Release the top claws on both sides using a trim stick as previously recommended.
