Knocking Noise From Fuel Tank Area

Service Category Engine/Hybrid System

Section Fuel System

YEAR(S)	MODEL(S)	ADDITIONAL INFORMATION
2017 - 2019	Highlander

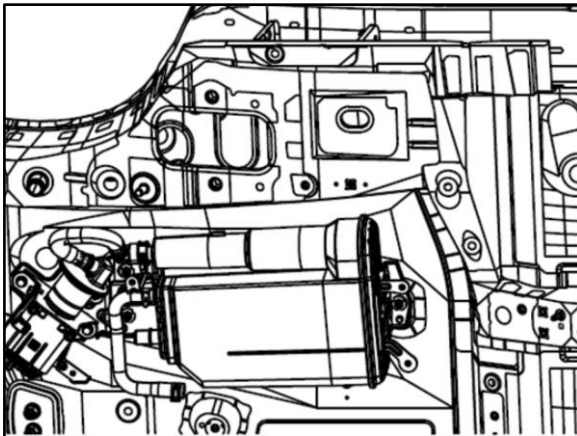
Figure 1. Without Pulsation Damper Valve Assembly Installed

The NEW part can be identified by the addition of a bracket and valve assembly attached to the charcoal canister.
