JTB00567NAS3

# TECHNICAL BULLETIN

501-02

Creak Noise From Front Bulkhead

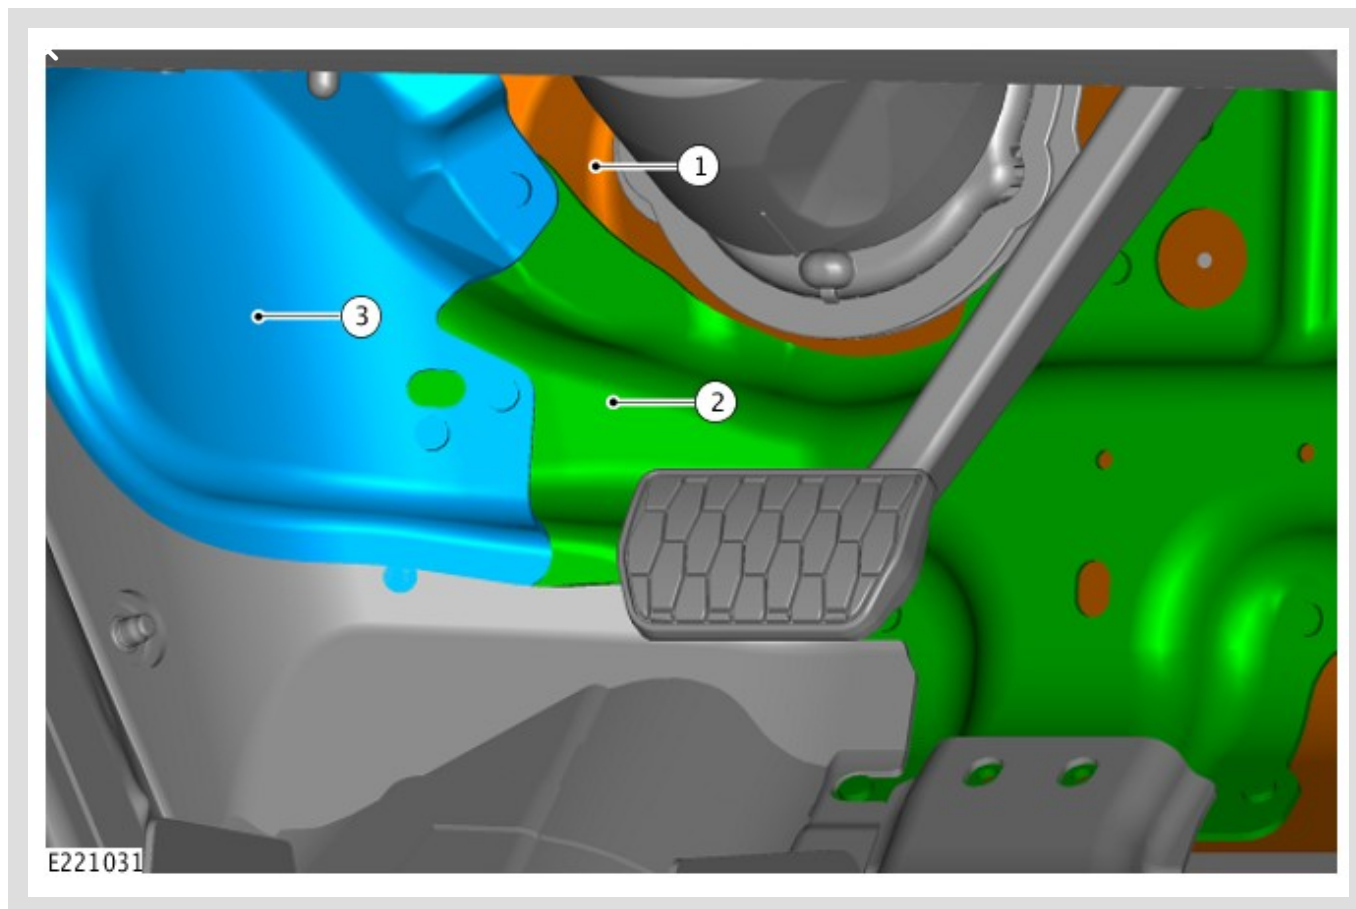
7

The illustration shows the order of the body panels.
