Technical Journal

TITLE:
Steering Assistance Temporarily Reduced, PSCM U30031C

REF NO: TJ 34142.5.0	ISSUING DEPARTMENT: Technical Service	CAR MARKET: United States and Canada	
PARTNER: 3 US 7510 Volvo Car USA		ISSUE DATE: 2019-02-12	STATUS DATE: 2019-02-18
FUNC GROUP: 6422	FUNC DESC: Steering gear, servo complete	Page 1 of 3

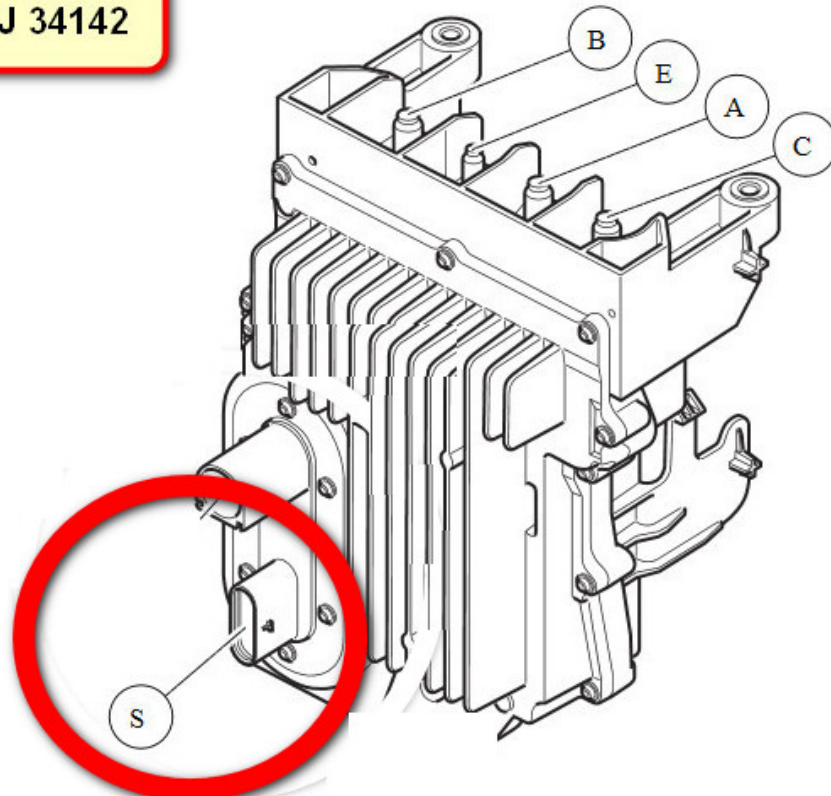
TJ 34142

* The DTC is caused by one of the internal switches in the battery control switch module (BCSM) is in the wrong position when cranking and it could result in symptom similar to poor main battery state of charge (SOC).

* Important to know, it is also required to reset of the BCSM by disconnecting the S connector on the BCSM (4/153) for 15 minutes and then reconnect it, see picture.
