# Technical Service Bulletin

## 91 Navigation, Bluetooth, smartphone interface, voice recognition, drive select, ACC, or cruise control is not available

91 19 44 2042506/6 March 8, 2019. Supersedes Technical Service Bulletin Group 91 number 17-48 dated September 1, 2017 for reasons listed below.

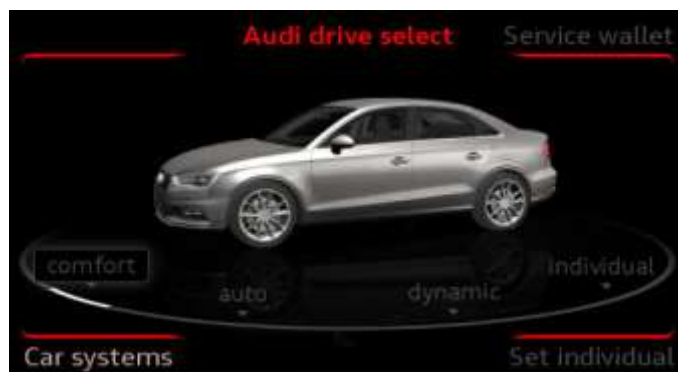
- Audi drive select functions cannot be selected (Figure 1).
- Cruise control does not work (except for A6 and A7) and **DTC P161200** (ECM incorrect coding) is stored in one or more of the control modules on the Powertrain CAN bus (address word 0003 (ABS)), (address word 0001 (ECM)), etc.).
- Navigation is not activated (Figure 2 and Figure 3).

**Figure 1.** Audi drive select functions unavailable and greyed out.

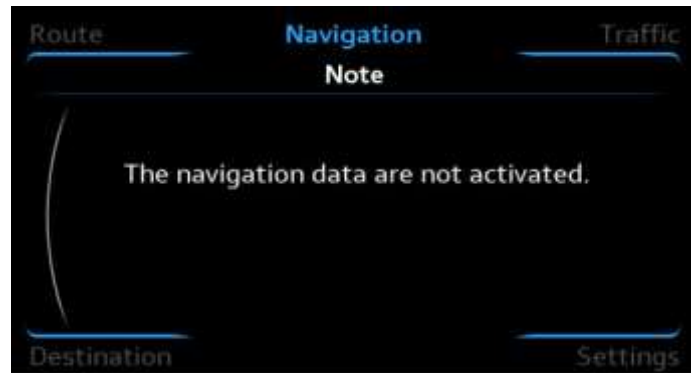
**Figure 2.** Navigation not activated message (Original MIB HMI).

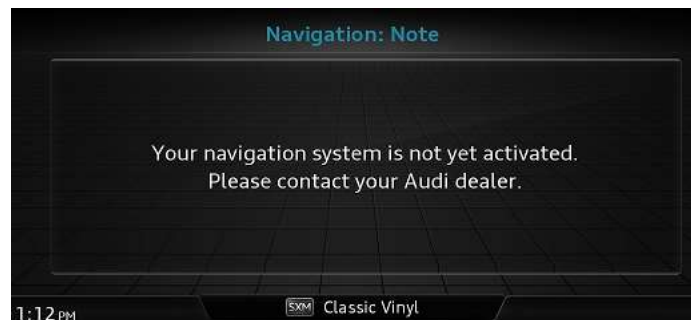
**Figure 3.** Navigation not activated message (New MIB2 HMI).

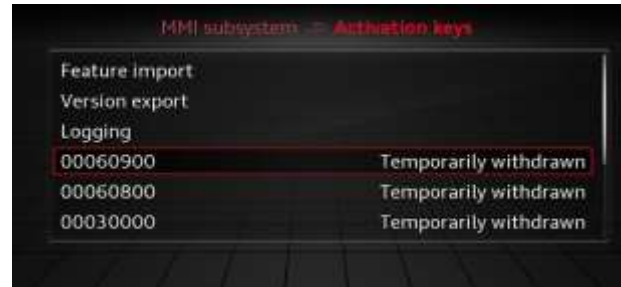
**Temporarily withdrawn or Temp illegal** = This indicates that the SVM activation test plan was not completed (Figure 4). This status is normal for all parts that have been swapped from a different vehicle. Perform the SVM Activations test plan as indicated below, under *Repair Procedure*.

**Figure 4.** Activation keys showing “Temporarily withdrawn”.
