TT7399EN
October, 2013
Page 1 of 7

SUBJECT: Transmission Control Module (TCM) Recalibration for Kenworth

MODELS AFFECTED: Kenworth T800, W900, and C500 models built between 1/25/13 - 07/15/13 and equipped Allison 4000 Series Product Family Transmissions and ISX Family 1 engines.

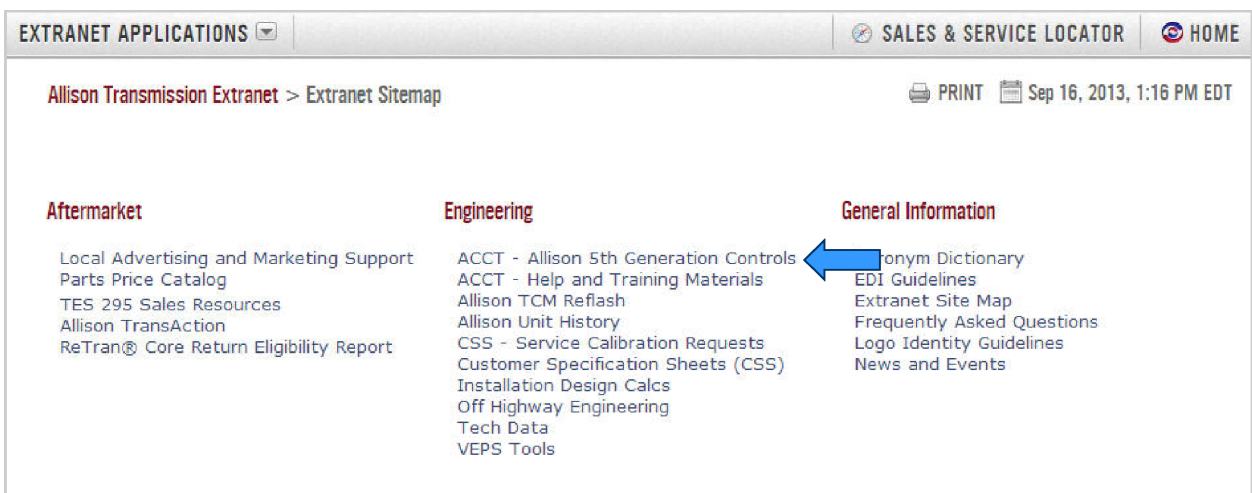
Figure 1. Launching ACCT

1. Log onto the Allison Extranet.
2. Launch the Allison Calibration Configuration Tool (ACCT) for Allison 5th Generation Controls. Refer to [Figure 1](#).

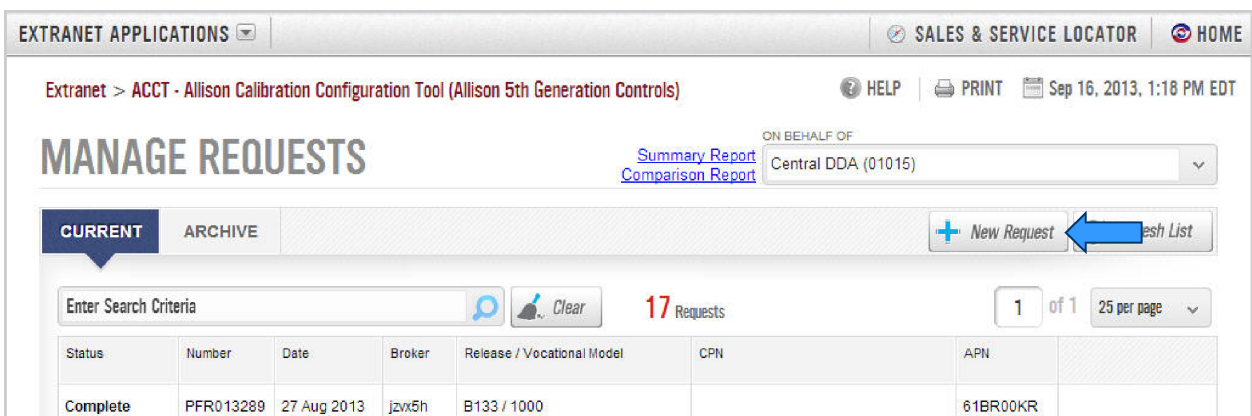
Figure 2. New Request

3. From the MANAGE REQUESTS screen, click on the “New Request” button.

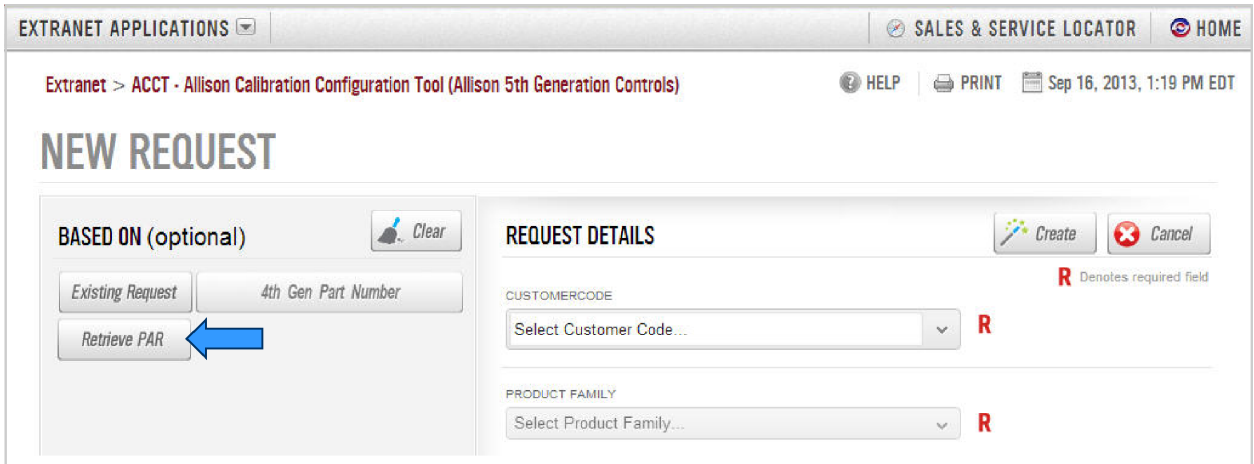
Figure 3. Retrieve PAR

4. In the NEW REQUEST screen, click on the “Retrieve PAR” button. Refer to [Figure 3](#).

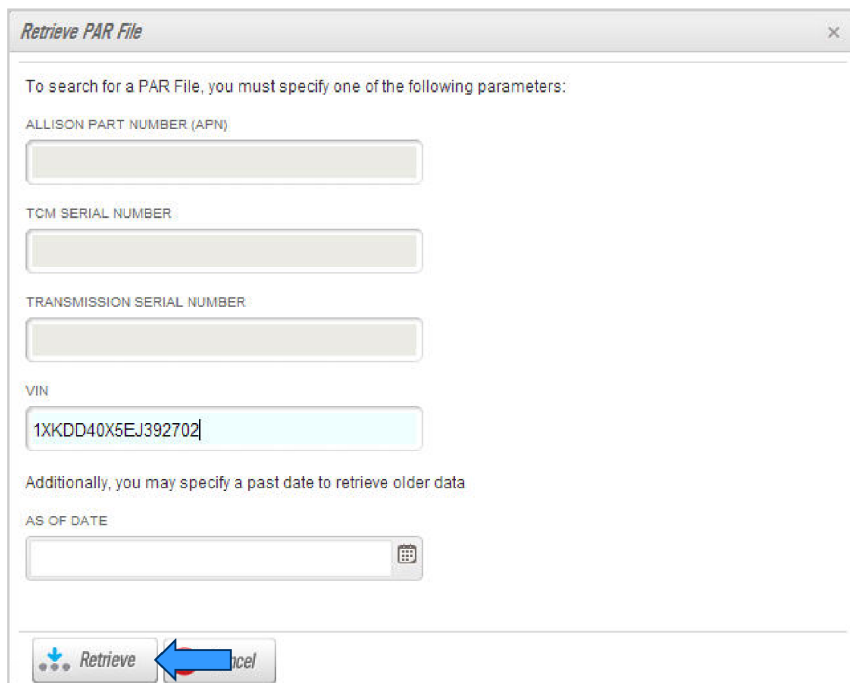
Figure 4. Retrieving PAR File

5. Enter either the Vehicle Identification Number (VIN) or TCM serial number into the appropriate parameter search field and the click “Retrieve” button.

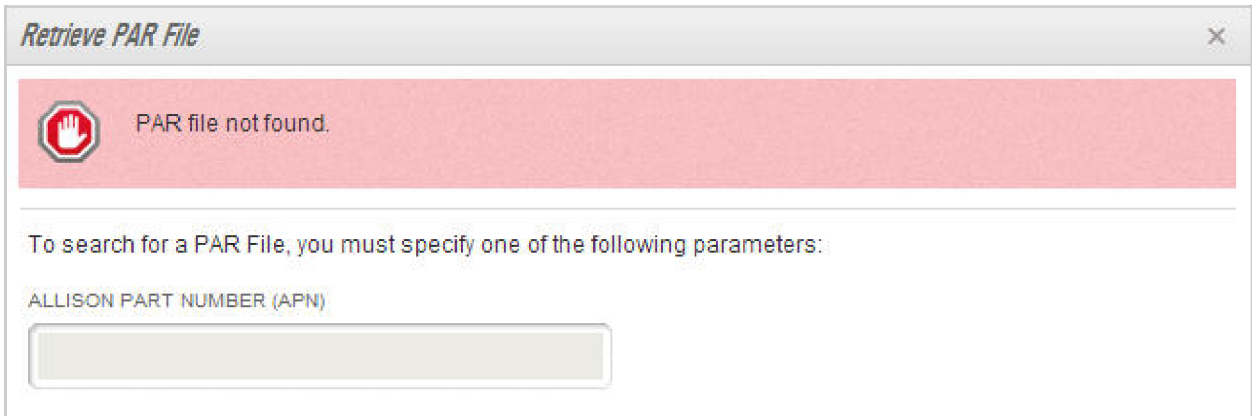
Figure 5. PAR File Not Found

- a. If the following message is displayed (refer to [Figure 5](#)), perform the actions in step 5b; otherwise, proceed to Step 6.

- b. Connect Universal Allison DOC[®] to the vehicle and make a Customer Modifiable Constant (CMC) change using the DOC reprogramming menu. Then, reconnect the laptop to the Internet and launch Allison DOC[®] to return the TCM calibration settings to the Allison server. Allow approximately 15 minutes then repeat steps 1 through 5. If this continues to be unsuccessful, contact the Allison Technical Assistance Center (TAC) at (800) 252-5283. Provide the Vehicle Identification Number (VIN) and TCM serial number.
6. Enter distributor code, product family, release, vocational model, TCM type, and Service for PAR file type in the REQUEST DETAILS screen. Click on the Create button.
