Technical Service Bulletin

91 MIB2 Standard Software Update Instructions (PR Code I8E)

91 19 29 2053598/1 January 25, 2019.

Model(s)	Year	VIN Range	Vehicle-Specific Equipment
All	2016 - 2020	All	MIB2 Standard

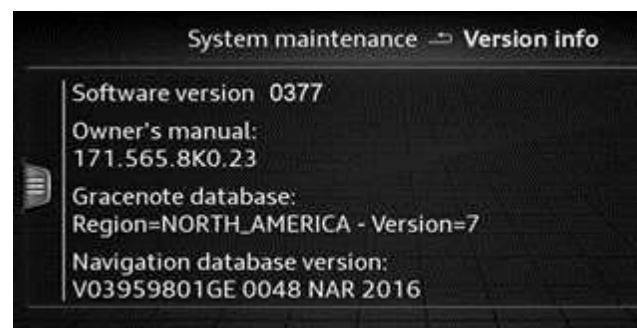
1. To save time, always verify the customer's MMI requires the software update before proceeding. In the MMI, go to *Menu >> Settings >> Left drawer option >> Version Information* (Figure 1). This applies to models using the new MIB2 user interface. The C7 PI uses the old user interface similar to MMI3G+ along with the newer MIB2 hardware. The software version for the older user interface is found under *Menu >> Setup MMI >> Version Information*.

Figure 1. MIB2 Software Version in MMI with new UI.
