Technical Service Bulletin

15 Oil leak from cylinder head - 2.9 and 3.0TFSI only

15 19 33 2053278/2 February 5, 2019. Supersedes Technical Service Bulletin Group 15 number 18-32 dated December 17, 2018 for reasons listed below.

Model(s)	Year	VIN Range	Vehicle-Specific Equipment
All	2018 - 2019	All	3.0 TFSI
All	2019	All	2.9TFSI

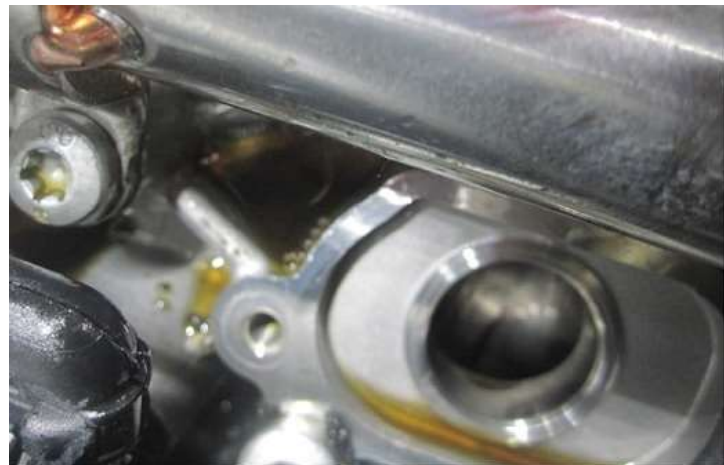
3. Remove the Audi valvelift system actuator of the affected cylinder.
 - A.** If there is a substantial quantity of oil below the Audi valvelift system actuator (illustration), the cause of the leak is the O ring of the Audi valvelift system actuator. Replace the Audi valvelift system actuator with O ring, clean the engine compartment and if necessary replace the noise insulation (if it is full of oil) (Figure 2).
 - B.** If there is no substantial quantity of oil below the Audi valvelift system actuator continue with Step 4!

Figure 2. Oil in the Audi valvelift system.

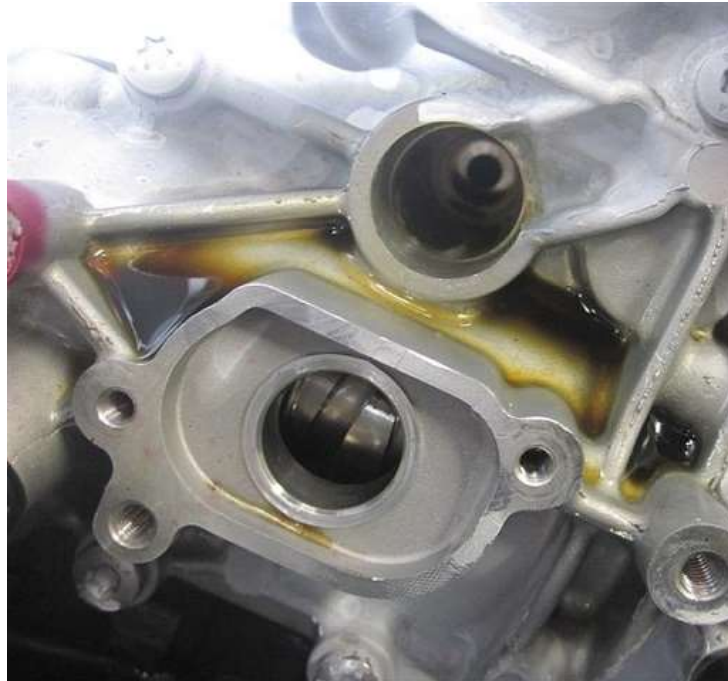
5. Locate the affected cylinder. Here oil should have gathered in the area of the injector (Figure 3) and the noise insulation should also be full of oil.

Figure 3. Locating the affected cylinder.

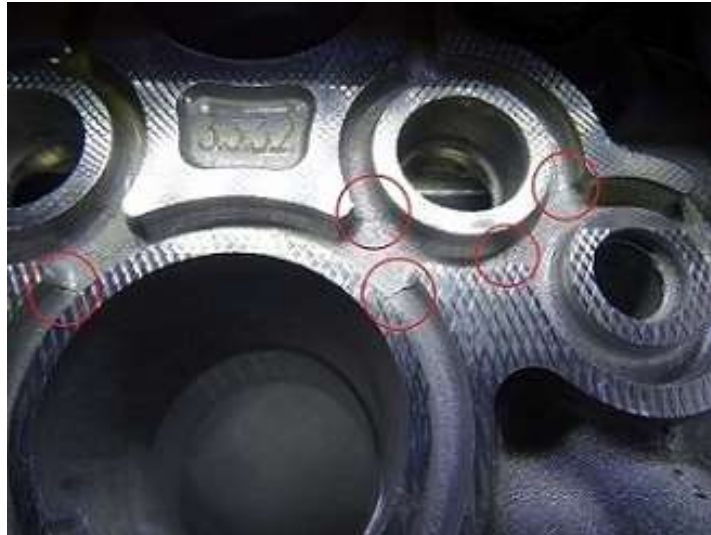
Metal shavings produced during manufacture in sealing groove between cylinder head cover and the cylinder head.

7. Inspect the seal groove in the cylinder head cover and remove any cast metal debris (Figure 5). The debris can be removed with a small flat screwdriver (Figure 6).

Figure 5. Before the repair.

Make sure not to damage the seal groove!

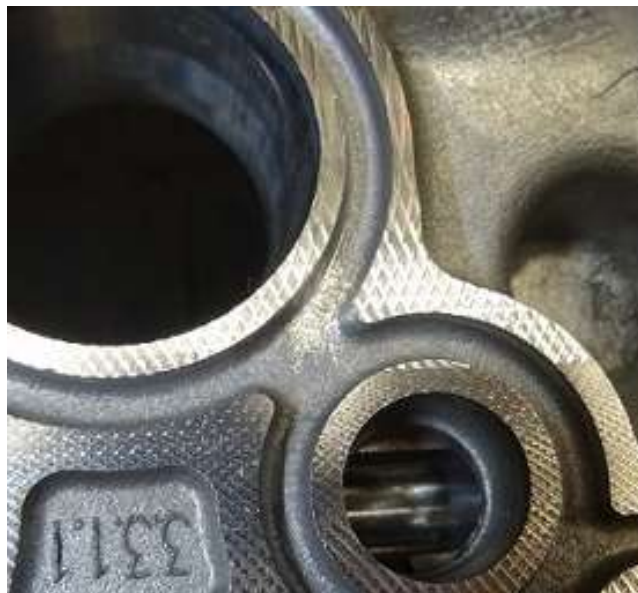
Figure 6. After the repair.

8. Install a new seal, re-assemble camshaft cover, clean the engine compartment, and if necessary replace the noise insulation (if it is full of oil).
