Emissions Recall Circular

Code: **WA00**

**Subject: 1999-2001 Volkswagen Golf/ Jetta and New Beetle
2.0 Liter Gasoline Engine Vehicles
Reprogramming of Engine Control Module and
Replacement of Malfunctioning Oxygen Sensor**

September 18, 2013

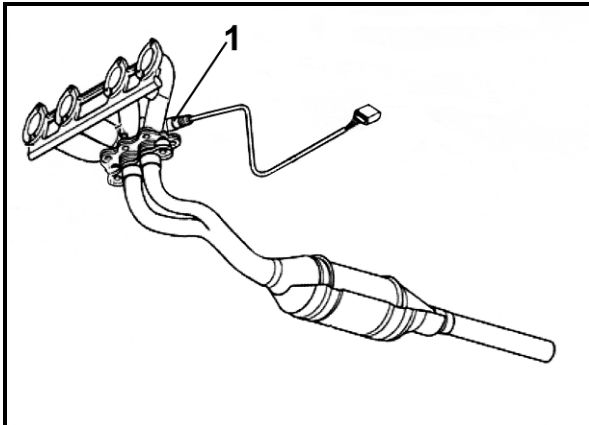
SECTION C – Front Oxygen Sensor Replacement

Volkswagen has found that the oxygen sensor in the upper part of the exhaust system could fail under certain conditions, potentially causing a vehicle to exceed Federal and/or California emission standards, or to experience increased fuel consumption. "Thermal shock" within the sensor caused by moisture accumulation could cause oxygen sensor failure. If the oxygen sensor fails, the vehicle's "check engine" light on the dashboard will illuminate.

The oxygen sensor failure could be caused by "thermal shock" within the sensor caused by moisture accumulation.

- Disconnect wire harness connector from oxygen sensor
- ← Use special tool 3337 to remove front oxygen sensor -1- from exhaust manifold

⚠ Note: Coat threads of new oxygen sensor, 06A 906 262Q, using anti-seize compound marked “safe for oxygen sensors”. Do not allow compound to enter slots on sensor body

- Install new oxygen sensor (06A 906 262Q) and tighten to 50 Nm (37 ft. lbs.)
- Reconnect oxygen sensor to wire harness;
proceed to SECTION D
