# Technical Bulletin

Model(s)	Year	Eng. Code	Trans. Code	VIN Range From	VIN Range To
Routan	2009-2012	All	All	All	All

58 12 03 October 26, 2012 2029303 Supersedes T.B. V581201 dated June 6, 2012 to update parts table.

### Sliding Door Trim Contacting Vehicle Rear Quarter

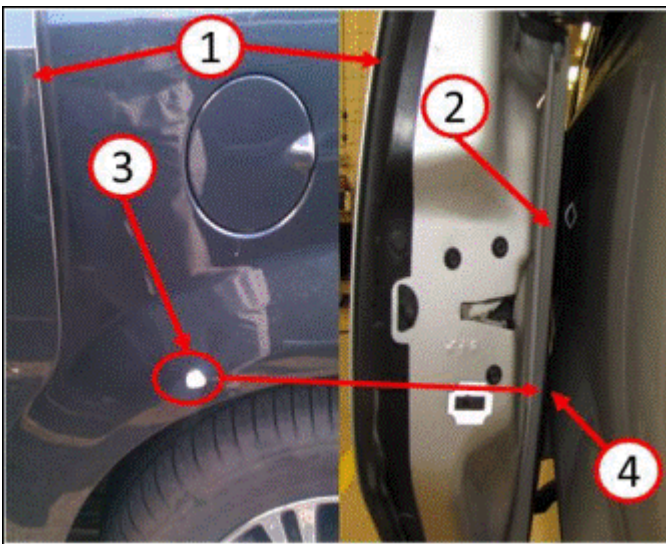
Figure 1

In some instances interior door panel to quarter panel contact has been noted on both left and right sides of the vehicle. Design clearances of the interior door panel are aggravated by heat which causes the door panel to relax and bow, which may contact the rear quarter panel (Fig. 1). In order to correct this condition and avoid costly paint repairs an additional retention point needs to be added to prevent the door panel bowing condition. If the customer describes the symptom, perform the Repair Procedure.

- 1- Sliding door
- 2- Interior door trim panel
- 3- Quarter panel contact point
- 4- Panel Clearance area

This bulletin involves installing an additional door panel retention point to prevent the door panel from bowing and contacting the body when the sliding door is opened.

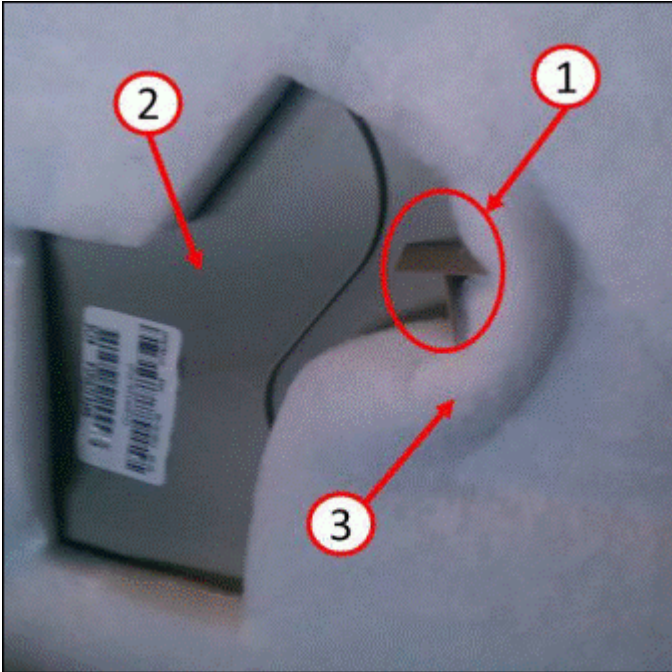
Figure 2

- 1- Standoff
- 2- Back side of door panel
- 3- Sound deadener

- Remove both side door trim panels.
- Remove the standoff from the back side of each door panel.

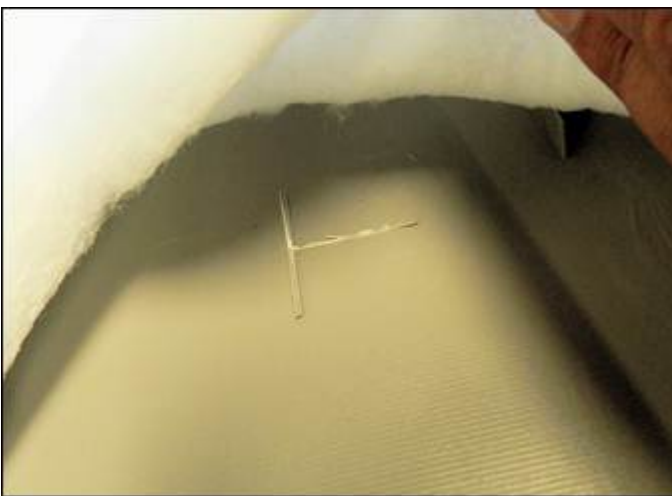
Figure 3

Standoff removed.

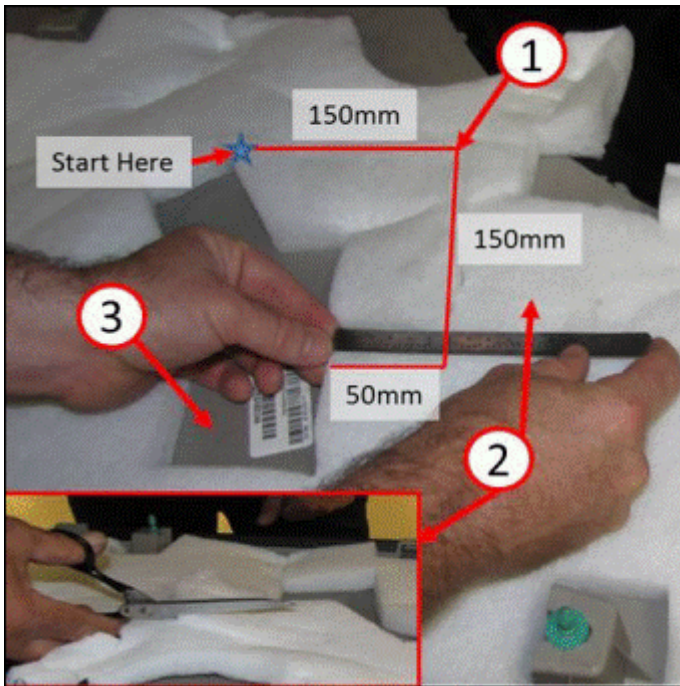
Figure 4

- 1- Cut line
- 2- Sound deadener
- 3- Back side of door panel

- Cut the sound deadener on the back side of each door panel as shown.

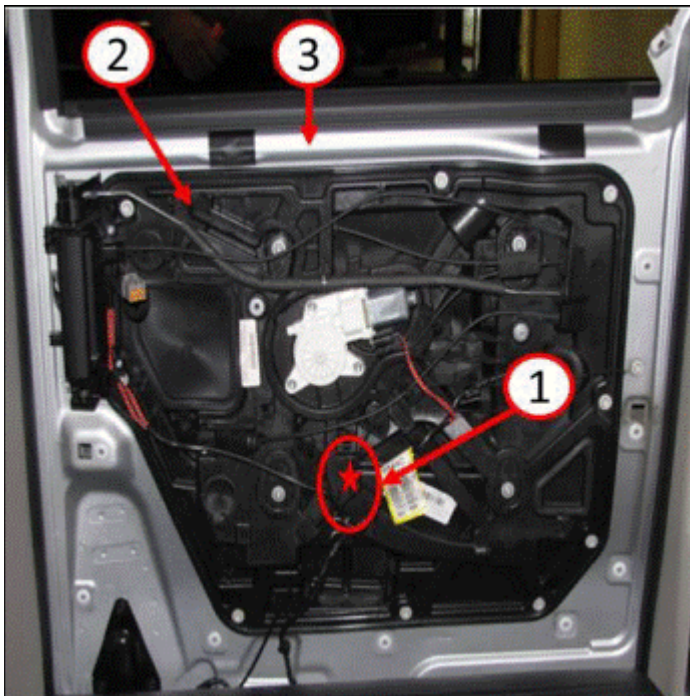
Figure 5

- 1- Drill location
- 2- Door carrier plate
- 3- Sliding door

- Carefully drill a 5/16" (8mm) hole through the carrier plate at the center of the formation/standoff (1) directly above the door module (if equipped) or just forward of the part number tag.

Make sure door window is in the full upward position before drilling hole in door carrier plate.

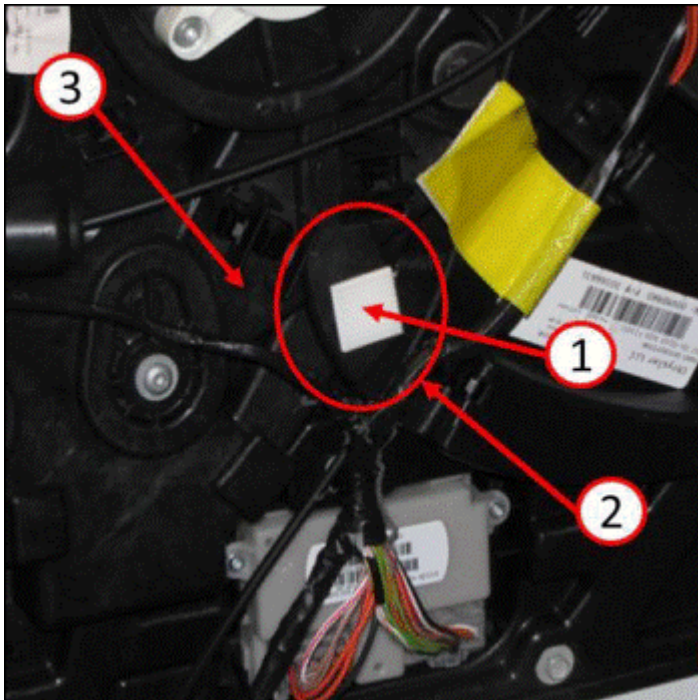
Figure 6

- 1- Dual lock push clip
- 2- Drilled hole location
- 3- Door carrier plate

- Fully seat the white dual lock push clips (1) from repair kit into the 5/16" (8mm) hole in the door carrier plate on both sides.

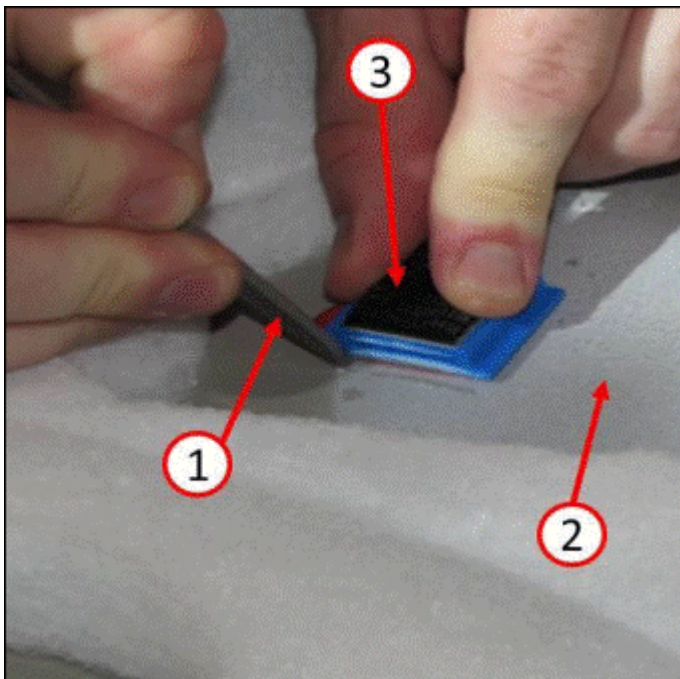
Figure 7

- 1- Scribe
- 2- Back side of door panel
- 3- Dual lock retaining clip

- Temporarily engage the dual lock halves in order to transfer the clip location from the module to the door panel using talcum powder or equivalent and scribe the clip location on the back side of the door panel.

Door trim panel(s) will need to be rough set and pressurized to transfer the contact location. Talcum powder should be applied to the approximate clip location on the back side of the door trim panel.

DO NOT engage dual lock halves and remove peel-off backing to locate the door trim panel side of the clip as this could result in an improperly placed clip while reinstalling the door panel. Improperly placing the clip can possibly destroy it if removal or repositioning is required. Do not use grease to transfer clip location as this will leach into the plastic surface of the trim panel and affect clip adhesive retention.

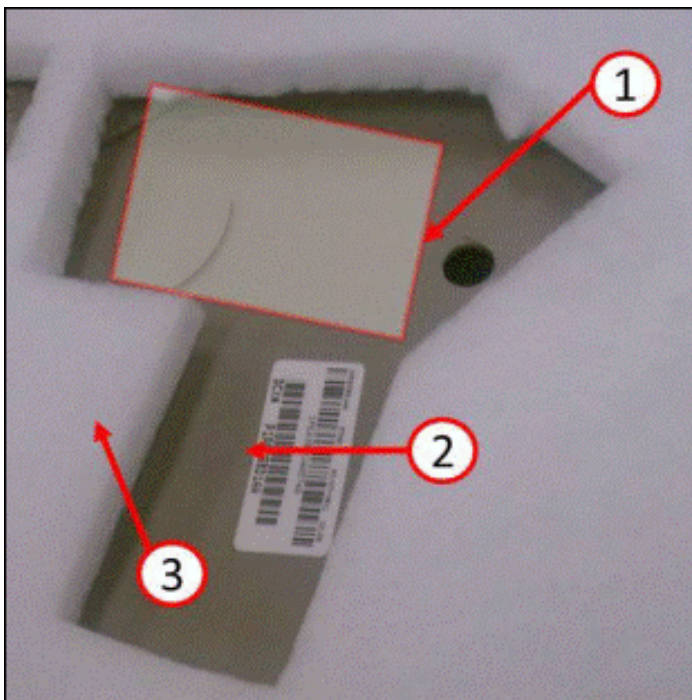
Figure 8

- 1- Clip bonding area
- 2- Back side of door panel
- 3- Sound deadener

- Clean the surface area (1) of both door trim panels to be bonded, with isopropyl alcohol.
- Once the alcohol has evaporated apply 3M™ 4298 adhesion promoter or equivalent to the surface area (1) where the dual lock adhesive backer will bond.

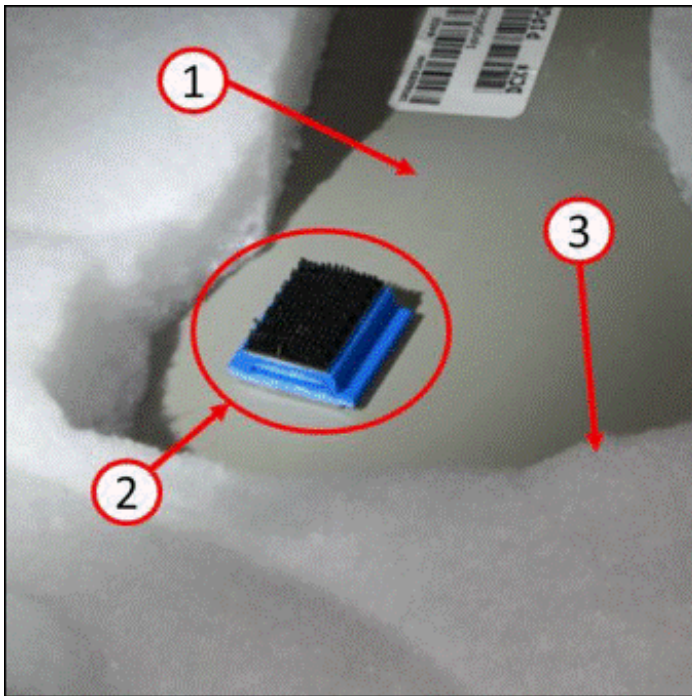
Figure 9

- 1- Back side of door panel
- 2- Dual lock clip
- 3- Sound deadener

- Firmly pressurize the blue dual lock clip at scribed location for 5 seconds after removing the protective backing off the adhesive side of the clip.

Let the blue dual lock clip cure for 1 hour before reinstalling the door trim panels.

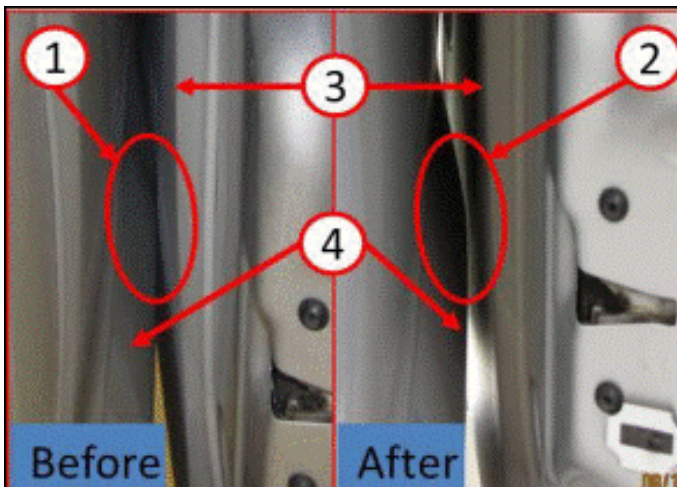
Figure 10

- 1- Contact point
- 2- Panel clearance
- 3- Door trim panel
- 4- Quarter panel

- Validate door trim panel clearance to rear quarter panel (Min Gap is 3/16” / 6mm).

Gap can be checked by applying modeling clay to the suspect area of the quarter panel.
