# Tech Tips

TT 61-12-04

**2007-2013 Eos – Convertible Top Inoperative With Faults  
03053, 03055, and/or 03057 Stored**

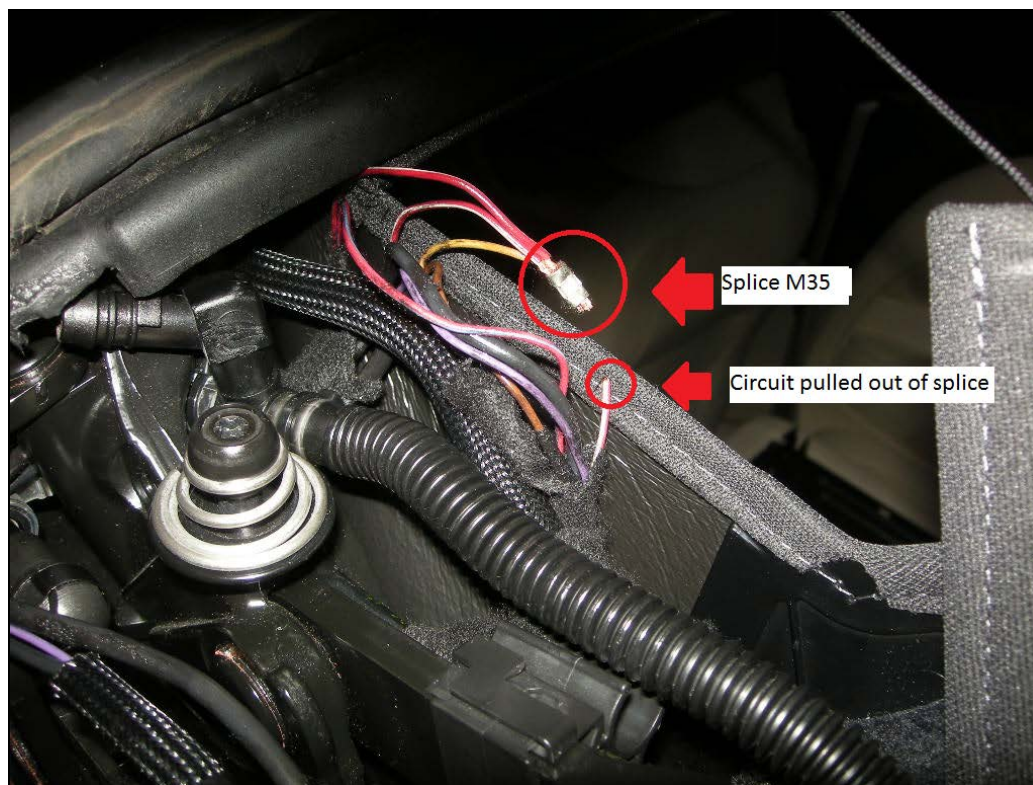
When diagnosing a customer concern of convertible top inoperative with faults 03053-008 “Left Roof Pillar Lock Sensor G558 implausible signal”, 03055-008 “Rear Window Frame Left Lock Sensor G560 implausible signal”, and/or 03057-008 “Rear Window Frame Opening Sensor G562 implausible signal” stored in convertible top, start by inspecting M35 splice in convertible top harness. Splice is located near left rear convertible top drain, as shown below.
