Technical Journal

Knocking noise from rear suspension, loose spring aid in upper spring seat

REF NO: TJ 23844.6.0	ISSUING DEPARTMENT: Technical Service	CAR MARKET: United States and Canada	
PARTNER: 3 US 7510 Volvo Car USA		ISSUE DATE: 2017-11-06	STATUS DATE: 2017-11-16
FUNC GROUP: 6525	FUNC DESC: Bushing	Page 1 of 4

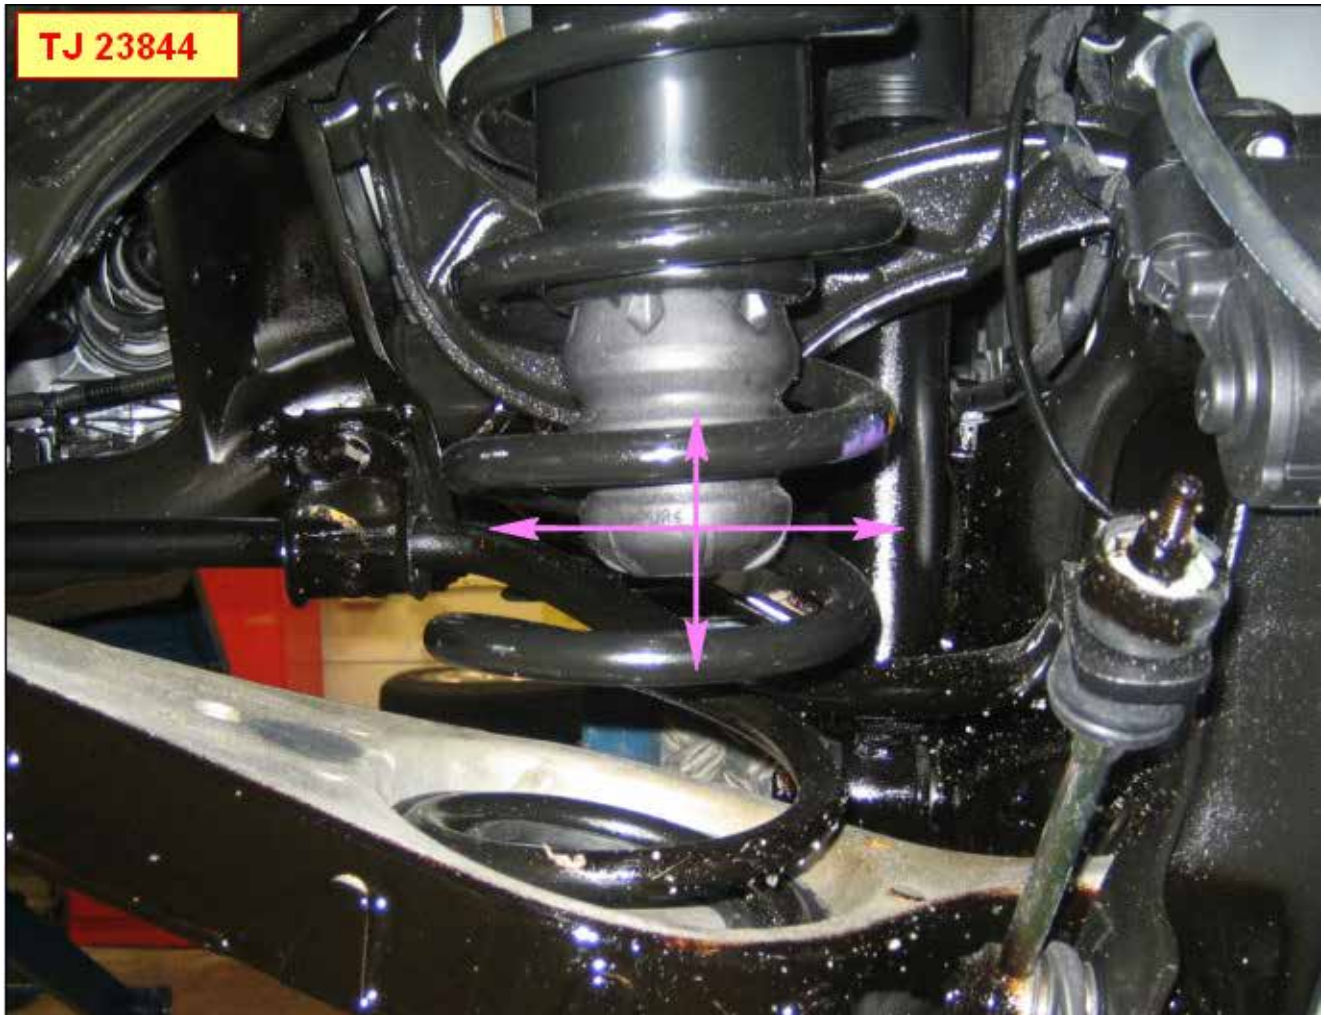
There may be a knocking noise from the rear spring aid (bump stop rubber) if the spring aid is loose in the upper spring seat installation.

Verify the symptom by wiggling on the rear spring aid (picture #1).
