Technical Service Bulletin

40 Noises from front end when steering

40 19 95 2053136/2 March 27, 2019. Supersedes Technical Service Bulletin Group 40 number 18-88 dated November 30, 2018 for reasons listed below.

Model(s)	Year	VIN Range	Vehicle-Specific Equipment
A3	2015 - 2019	All	Not Applicable

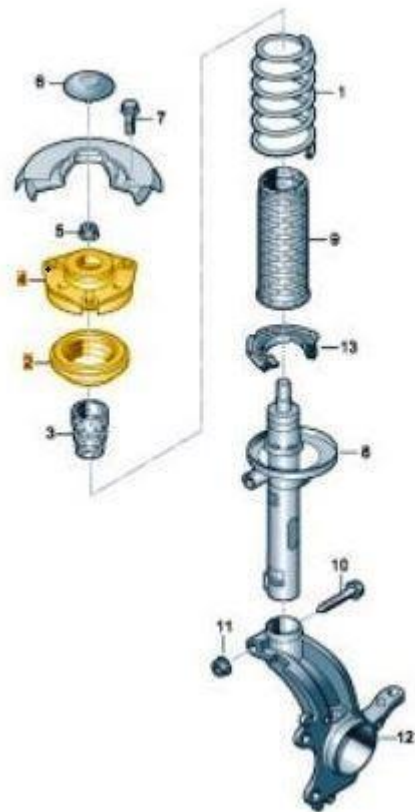
The axial deep-groove ball bearing overlaps the suspension strut mounting. Over time the overlap can cause noises.

Figure 1. Suspension strut mounting and axial deep-groove ball bearing.

Tip: Axial deep-groove ball bearing and suspension strut mounting must always be replaced together. The two components must always be replaced on both sides (right and left).

1. Replace the axial deep-groove ball bearing (Figure 1, position 2) and the suspension strut mounting (Figure 1, position 4) according to the Elsa Repair Manual.

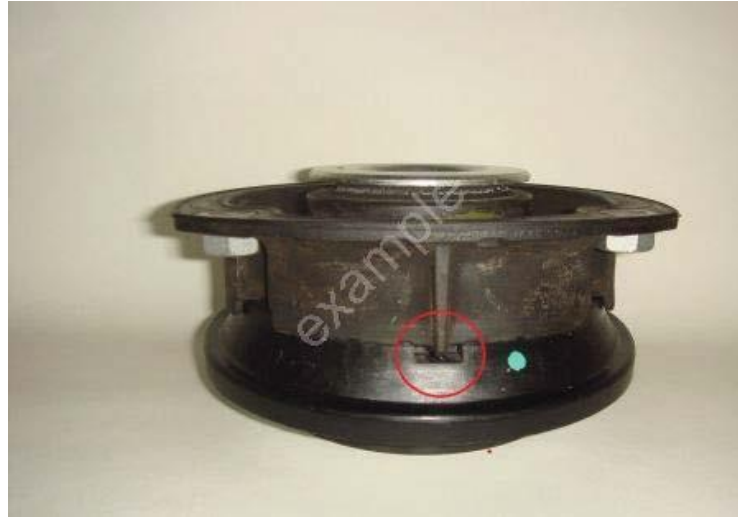
Figure 2. The correct installation position of suspension strut mounting and axial deep-groove ball bearing.

2. Ensure the correct installation position when assembling the suspension strut mounting and the axial deep-groove ball bearing. The bar of the axial deep-groove ball bearing must be central in the groove of suspension strut mounting (Figure 2).
