Preliminary Information

PIP5472F Short Duration Misfire - Rough Idle - MIL On During Cold Start - P050D

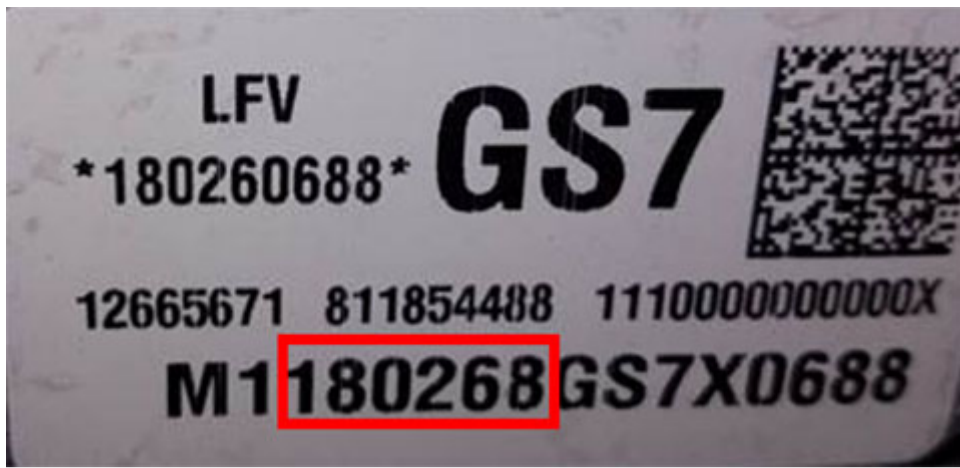
Example Engine Unit Number:

The first digit = engine plant.

The second digit reflects the shift, in this case 1 = First Shift

The third and fourth digits reflect the model year, in this case 18 = 2018

The fifth, sixth and seventh digits reflect the day of that calendar year 026 = 26th day of 2018 calendar year (build date)

If the engine you are working on was built on or after 17135, the SHLA's (Stationary Hydraulic Lash Adjuster) should not be replaced for this concern.

If the engine you are working on was built before 17135, then replace all Exhaust SHLA's. (Stationary Hydraulic Lash Adjuster)
