OM651 Exhaust Bracket Cracking

Topic number LI49.10-N-060969

Validity Sprinter Model 906 with engine OM651

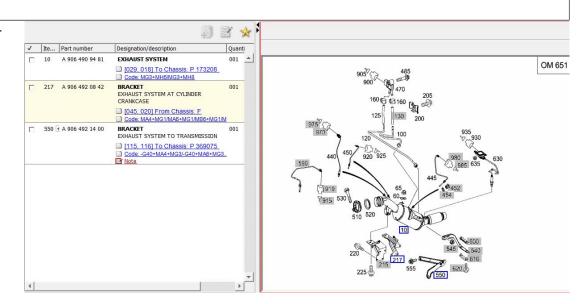
EPC OM651 exhaust. JPG:

- 1 Exhaust bracket to transmission (DPF to Transmission) cracked / broken (Pic.1)
- 2 Transmission bell housing cracked / broken (Pic. 2)
- 3 Exhaust bracket to cylinder crankcase (DPF to Engine) cracked / broken (Pic. "EPC OM651" #217)

1 - Inspect and replace exhaust bracket to transmission (DPF to Transmission) as needed. (Pic. "EPC OM651" #550) & (Pic. 3)

- 2 Inspect bell housing for damage and replace as needed. (Pic. 2)
- 3 Inspect and replace exhaust bracket at cylinder crankcase (DPF to Engine) as needed. (Pic. "EPC OM651" #217) Installation sequence of the new exhaust brackets are crucial.

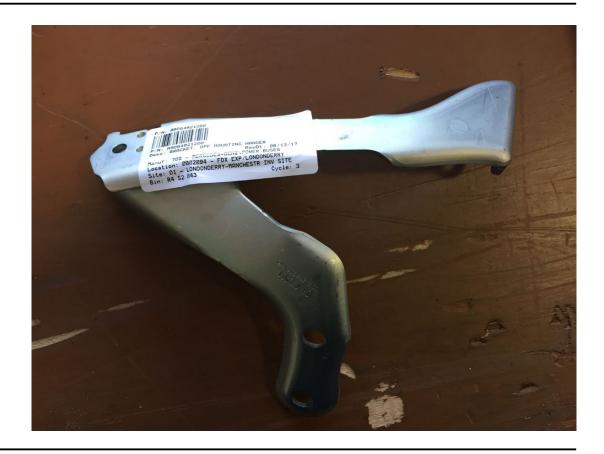
Pic 4.JPG:

Pic 4.JPG	DPF bracket to transmission has extra hole for mounting
Pic 5.JPG	DPF bracket to transmission has extra hole for mounting see part number
Pic 6.JPG	DPF bracket to transmission rear view
Pic 7.JPG	Location of mounting screws
Pic 8.JPG	Loaction of mounting screws view 2
Positioning of the exhaust system.JPG	Positioning of the exhaust system
Tightening sequence of the exhaust system.JPG	Tightening sequence of the exhaust system

Example pictures of new exhaust bracket to transmission (DPF to Transmission) (Pic. 4, 5, & 6)
