Vehicle does not start, battery discharged.

Topic number	LI54.10-P-066341
Version	3
Function group	54.10 Battery, power supply, voltage converter
Date	08-08-2017
Validity	BR231 and BR172
Reason for change	Examples added
Reason for block

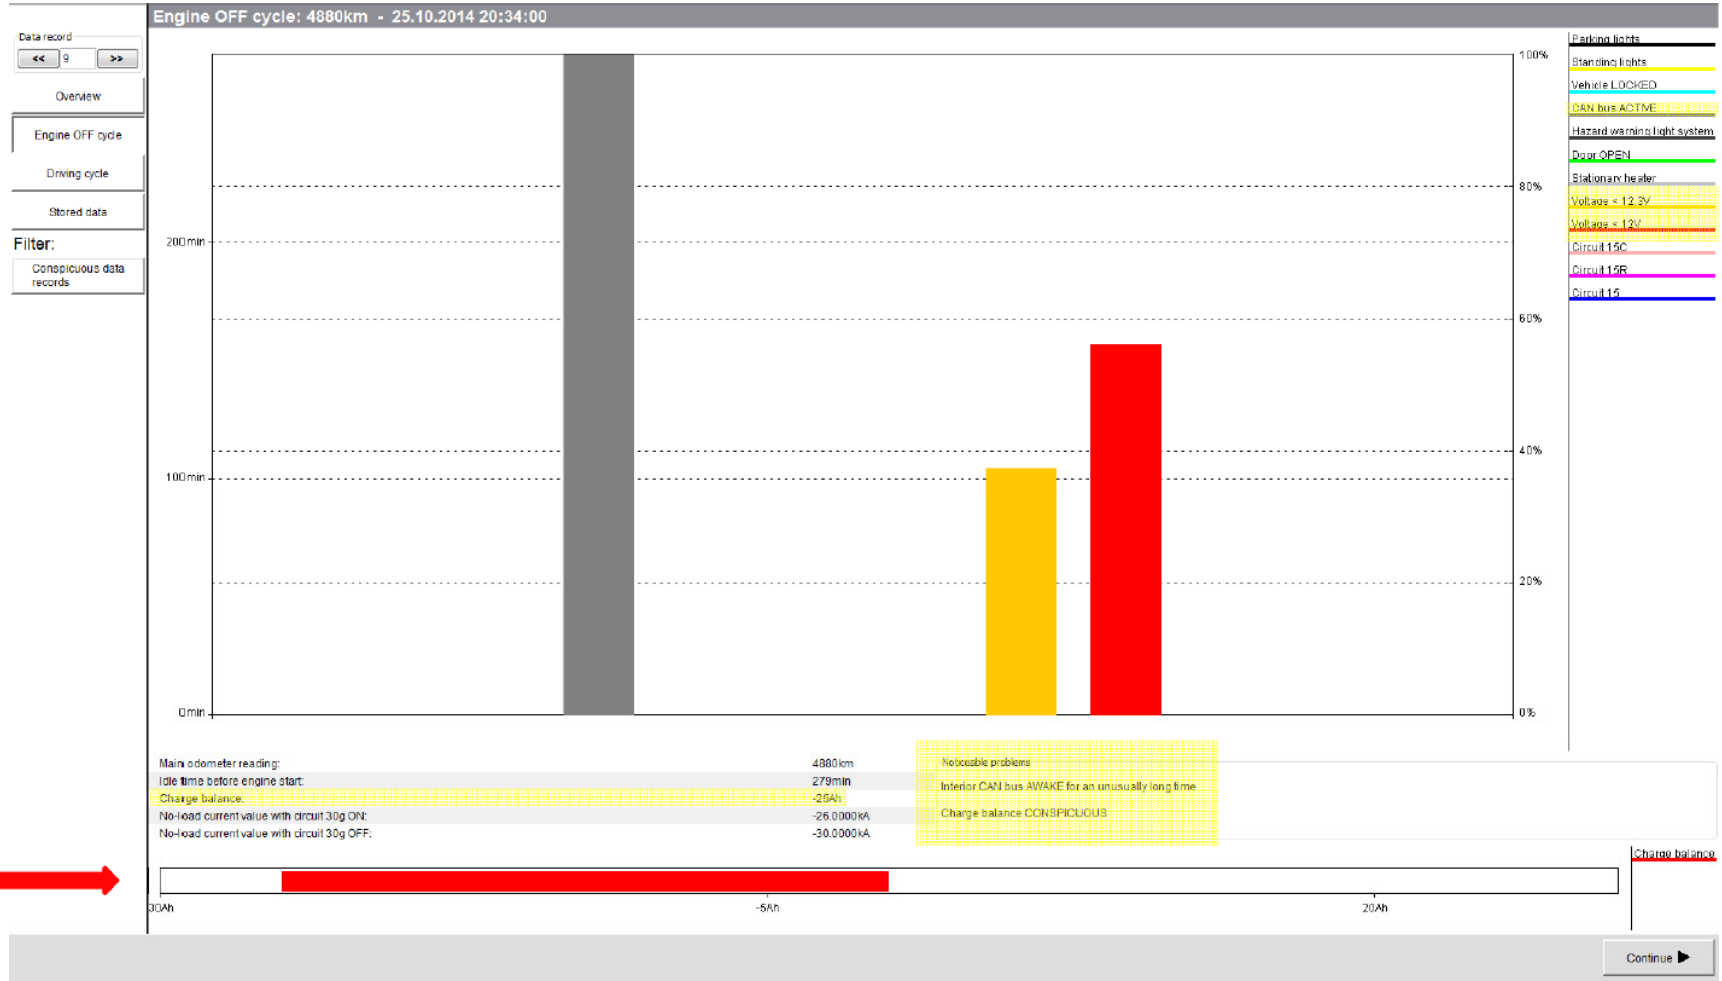
BODY-CAN keeps awake – technical issue
