Service Campaign Bulletin

Campaign No. 2017020019, August 2017

SUBJECT: **Model 166, Model Year 2016 - 2017**
Replace Fasteners for Rear Axle Camber Adjustment

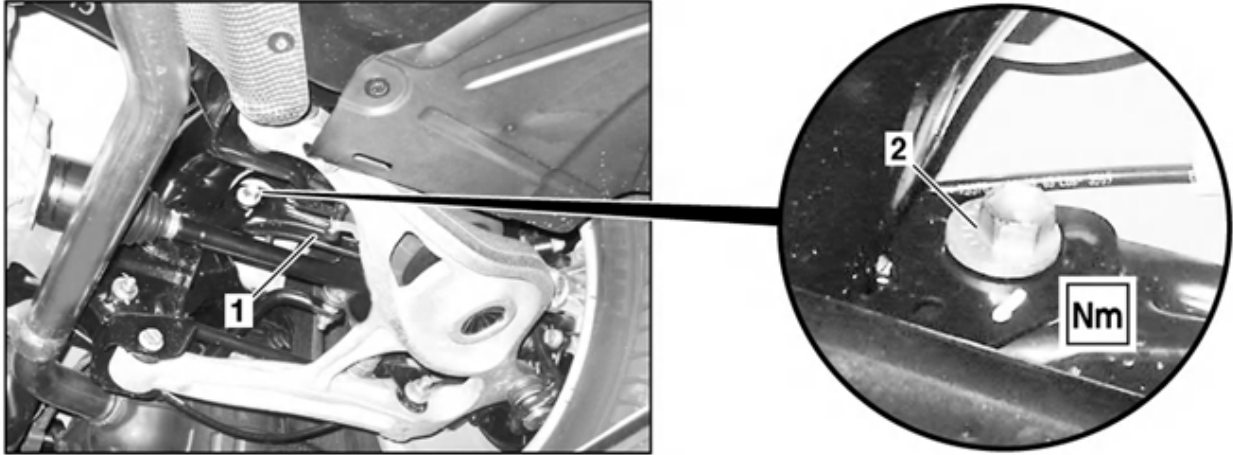
Figure 1

Daimler AG ('DAG'), the manufacturer of Mercedes-Benz vehicles, has determined that on certain GLS-Class (166 platform) vehicles, the threaded connection for the camber adjustment on the left and right of the rear axle does not correspond to specifications. The screws' anti-corrosion protection may have been worn during assembly. As a result, the threaded connection may no longer be correctly tightened during subsequent camber adjustments. An authorized Mercedes-Benz dealer will replace the left and right threaded connections on the affected vehicles.

Replace bolt and nut (2) of tie rod (1) for rear axle (figure 1).
