# Technical Service Bulletin

## 01 Coolant loss from coolant valve, engine warning light on, "Limp Home" mode active, cabin heating is insufficient

01 19 99 2033806/9 January 10, 2019. Supersedes Technical Service Bulletin Group 01 number 16-80 dated October 13, 2016 for reasons listed below.

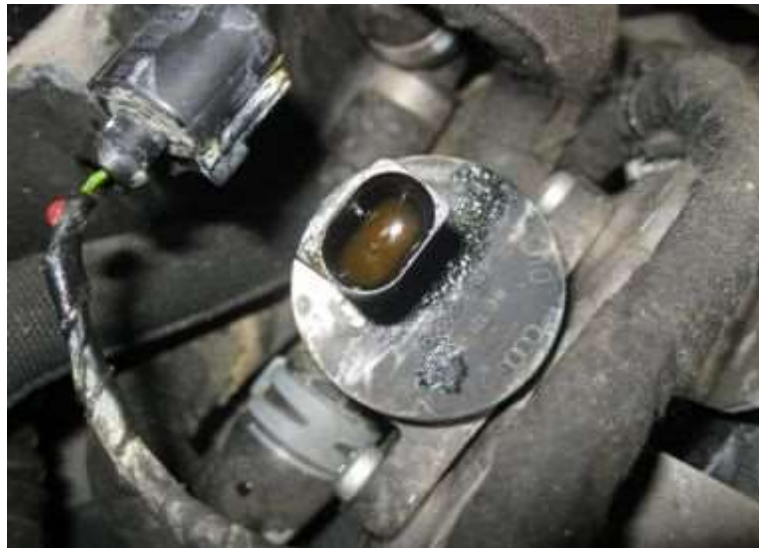
Inspection of the coolant control valves N82, N509, or N488 reveals the presence of coolant inside the electrical connector as shown in the illustration (Figure 1).

*Figure 1. Coolant residue in the connector housing of the coolant regulating valve.*

1. Diagnose the defective coolant valve (N82, N509, or N488) using Guided Fault Finding (GFF) where the stored DTCs are found.
2. Replace the defective coolant valve.

**Tip:** Check the connectors, wiring harness, and connected control units for coolant damage. Perform repairs as necessary.

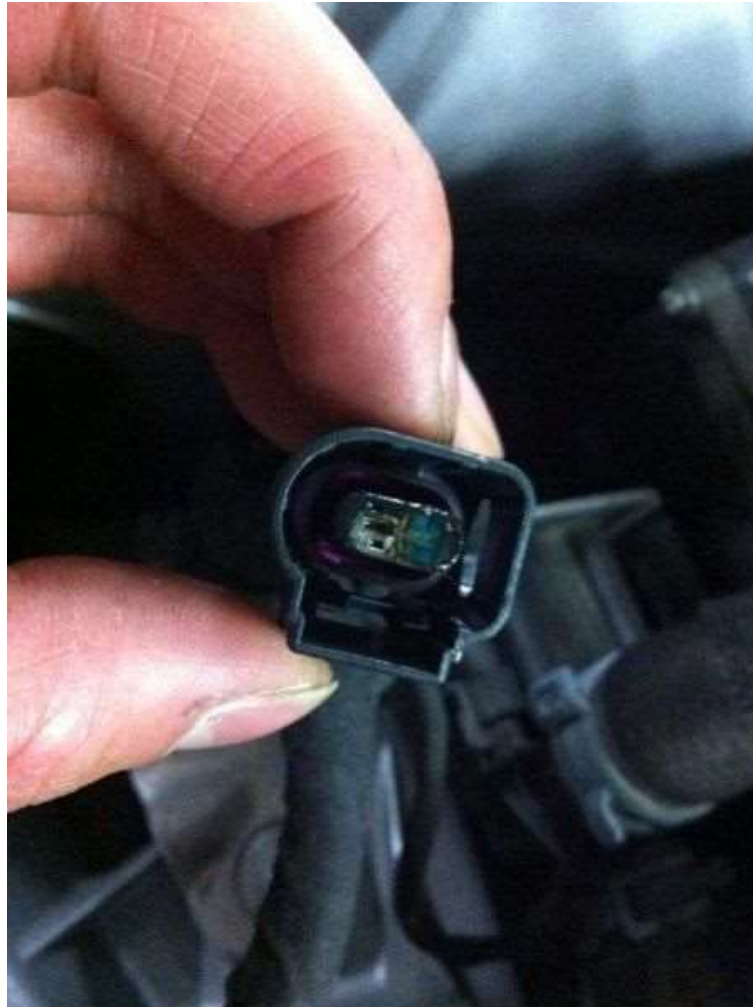
The connectors, wiring harness, and/or connected control units may have been damaged from exposure to coolant (Figure 2).

**Figure 2.** Corrosion formation on the connector pins.
