## Technical Tip

<b>Topic</b>	20-13-04TT - MIL ON with DTCs P2400 or P2404
<b>Market area</b>	United States 444 Volkswagen of America, Inc. (6444)
<b>Brand</b>	Volkswagen
<b>Date</b>	September 01, 2017

### MIL ON with DTCs P2400 or P2404

Model(s)	Year	Eng. Code	Trans. Code	VIN Range From	VIN Range To
Touareg	2011-2014	3.6L (CGRA)	All	All	All

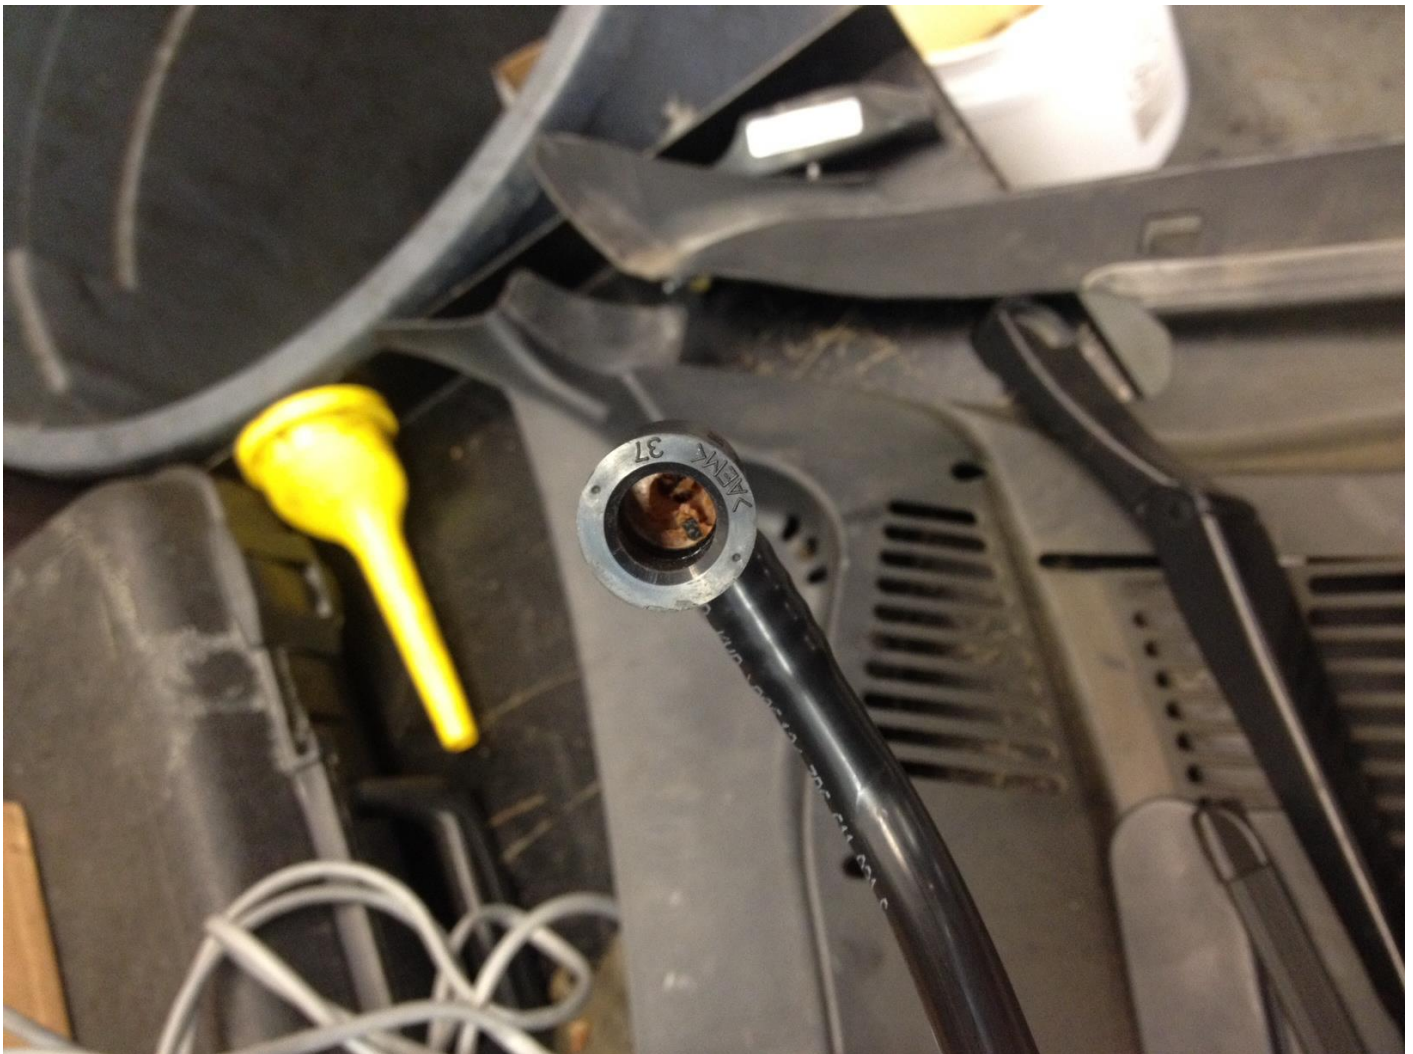
The following DTCs P2400 and/or P2404 may be set by faulty Coolant Pump Change Over Valve.

Example of coolant in the vacuum supply line.

The coolant pump has a vacuum controlled servo to control the flow of coolant. If the diaphragm fails, coolant can get into the vacuum supply line for the Leak Detection Pump (LDP). With a hand held vacuum tool, apply vacuum to the coolant pump vacuum port. If it will not hold vacuum, replace the coolant pump and the vacuum supply line as necessary and retest operation.
