**R89910: Tailgate Lift Arms (Drive Units)
Model Year 2018 – 2019 XC60**

Title	Inspection and replacement of "drive units", tailgate lift arms	Page:	1 (5)
Action

**Recall R89910: Tailgate Lift Arms
Model Year 2018-2019 XC60**

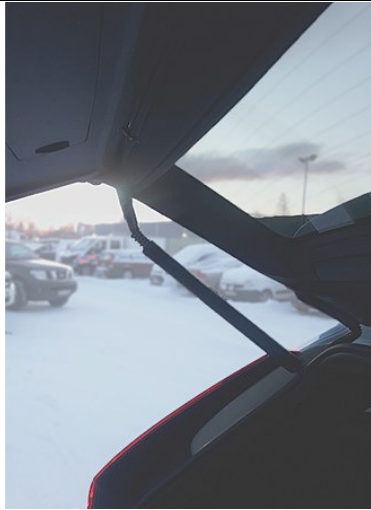
**Condition 3**

If motor, power operated tailgate looks according to image, the tailgate must not be closed.

When dismantling the broken lift arms see attached instruction video in QB-R89910 in TIE. **Note: Use tape on the metal eyelets in the tarp to prevent paint damage.**

Then both lift arms are to be replaced according to Vida:

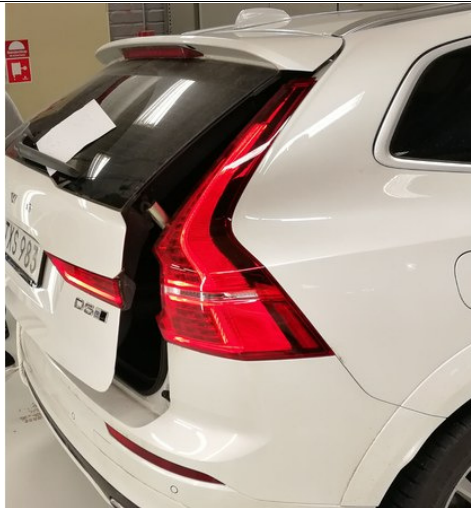
**Condition 3**

If motor, power operated tailgate looks according to image, do not operate tailgate.

When dismantling the broken lift arms see attached instruction video in QB-R89910 in TIE. **Note: Use tape on the metal eyelets in the tarp to prevent paint damage.**

Then both lift arms are to be replaced according to Vida:
