### Sensus ICM display black and DTC CEM-U015600 set

REF NO: TJ 25872.11.1	ISSUING DEPARTMENT: Technical Service		ARKET: s and Canada
3 US 7	PARTNER: '510 Volvo Car USA	ISSUE DATE: 2018-07-07	STATUS DATE: 2018-08-03
FUNC GROUP: 3919	FUNC DESC: Miscellaneous	Page	1 of 3

## Technical Journal 25872.11.1

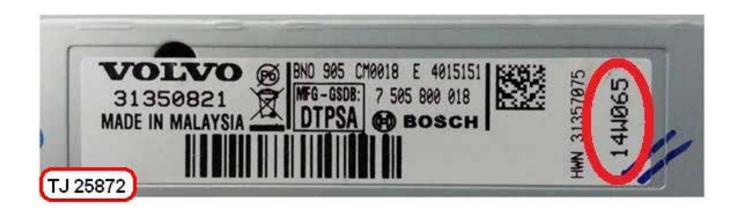
File Name	File Size
ICM TJ25872.jpg	0.0408 MB

The Sensus 7" ICM display may be completely black at start-up. No backlight or climate information present. No sound or functionality from the Sensus Infotainment system. DTC U015600 is set permanently in the CEM. This DTC may also be set in the CCM and/or DIM.

Analysis has shown that this symptom was caused by a NAND memory chip fault. There was a change to the NAND memory chip type, together with an improved ICM software has been introduced to prevent this symptom. Implemented into production and aftermarket from 2012-05-14 and structure week 2012w20-

If the above described symptom would occur, with permanently set DTC, please replace the ICM and perform an ICM software reload to solve this symptom. If the DTC is set intermittently and the ICM is possible to recover, the ICM should not be replaced with reference to this TJ. Fault tracing should then be performed as per VIDA symptom based fault tracing and VIDA DTC fault tracing.
