## Fuel guage jumps from 3 bars to 1

Topic number	LI54.30-N-066583
Version	1
Design group	54.30 Instrument cluster, display instruments, hazard warning device
Date	06-23-2017
Validity	All 906 with SA code KB7 (93 Liter Tank)
Reason for change	
Reason for block

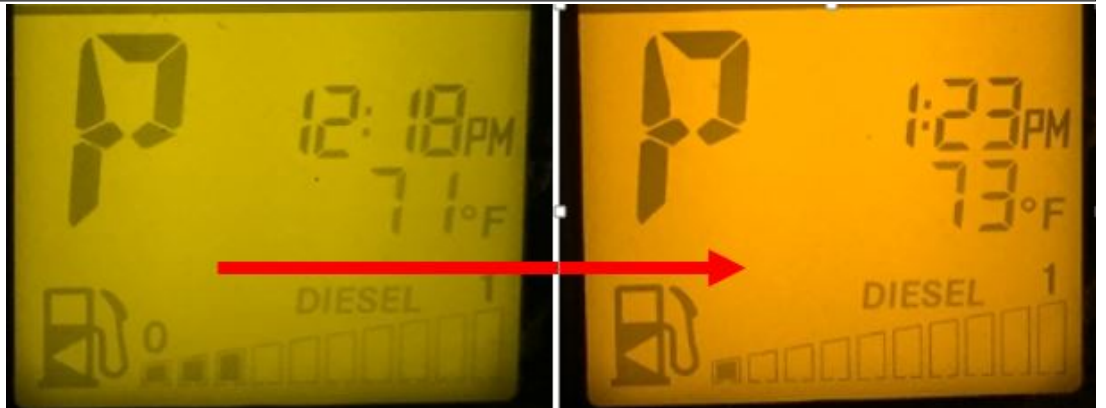
Fuel Guage.JPG:

Customer complains that the fuel guage will jump from 3 bars to 1 and trigger the "low fuel" warning lamp.

Attachments	
File	Description
Fuel Guage.JPG	Fuel guage skips fuel bar indicator

Hysteresis calculations within the instrument cluster software are not optimized.

**Note: DO NOT REPLACE ANY PARTS !!!!!**

A Xentry Add-on / Software optimization will be released by Q4 of 2017.
