## Installation position of fender liner twisted at rear

Topic number	LI88.10-N-062698
Version	2
Design group	88.10 Fenders
Date	06-09-2017
Validity	Model 447
Reason for change	Distribution revised
Reason for block

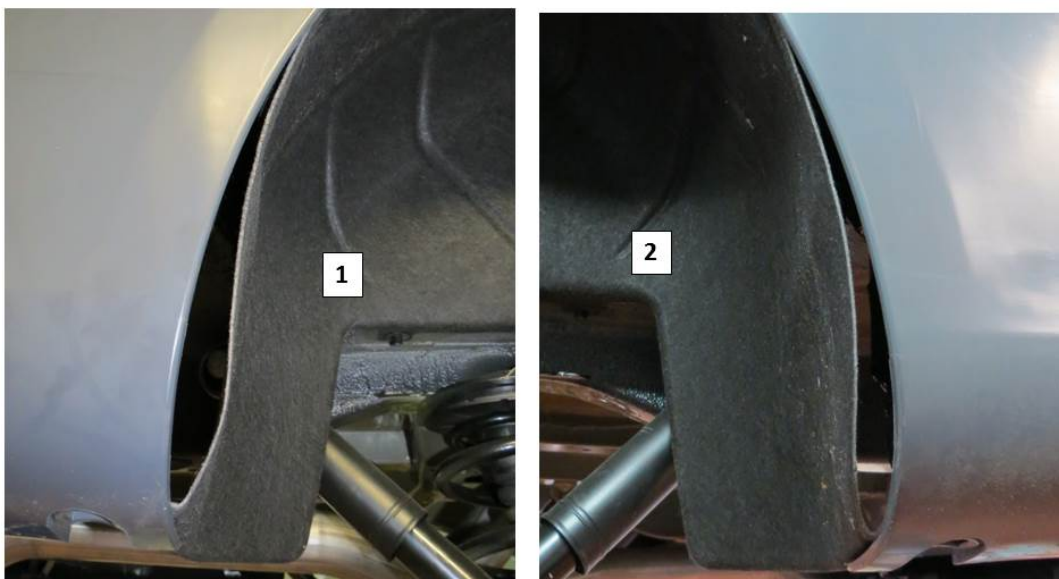
01.jpg:

Installation position of fender liner (1 and 2) twisted at rear (see picture 01.jpg).

Attachments	
File	Description
01.jpg	Fender liner at rear twisted

The fastening of the fender liner (1 and 2) on the bumper can be optimized.
