Engine diagnosis warning lamp active, malfunction at exhaust back pressure sensor

Topic number	LI07.04-N-066219
Version	3
Design group	07.04 Sender, Feeler, Sensors
Date	07-13-2017
Validity	906 with Engine 642 and 651
Reason for change	Added DTCs and example of incorrect reading
Reason for block

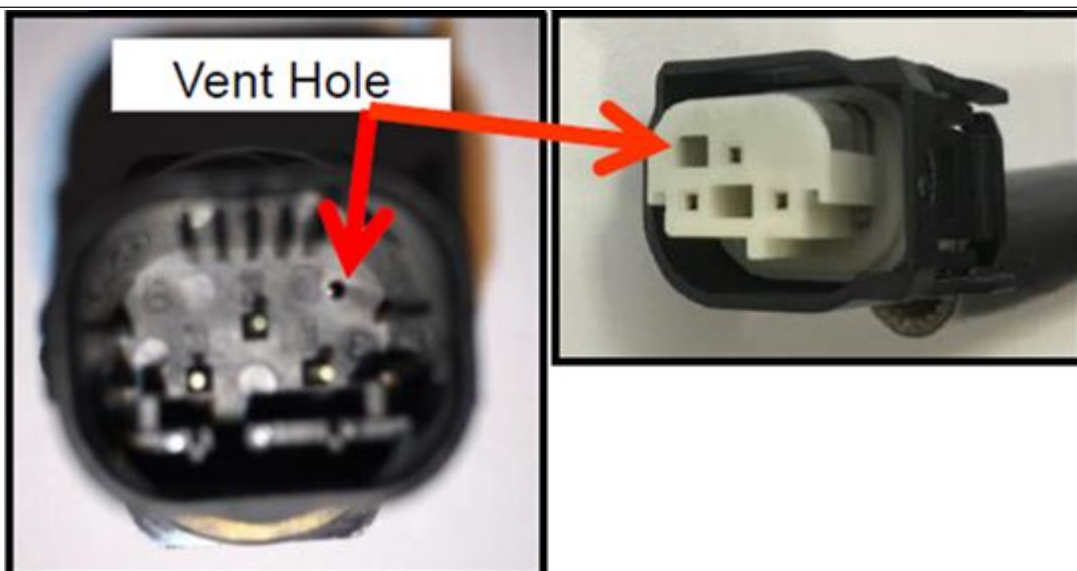
vents.JPG:

Although the sensors look the same and will fit in the same locations they are different and the vehicle may have the incorrect sensor installed.

Attachments	
File	Description
vents.JPG	Relative pressure sensor with vent hole shown

A009 153 50 28 - (with vent hole next to contact springs at sensor) *

A009 153 51 28 - (with vent hole next to contact springs at sensor) *

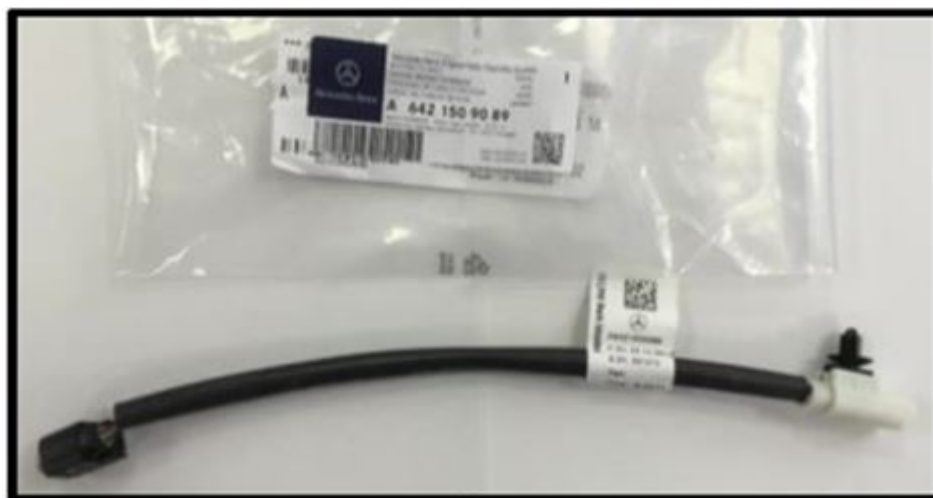
harness.JPG:

Attachments	
File	Description
harness.JPG	Engine Wiring harness

Note: Engine wiring harness - A642 150 90 89 may be required, check EPC
