# XENTRY TIPS

## COMAND Online: After map update is aborted, navigation no longer functions

Topic number	LI82.85-P-066769
Version	1
Design group	82.85 Navigation and Communication system (CNS, ICS, COMAND, FleetBoard)
Date	07-18-2017
Validity	NTG4.5 COMAND Gen2 and Gen3: Model 117, 156, 166, 172, 176, 204, 207, 212, 218, 231, 246 with codes 512, 514, 527 and codes 803, 804, 805, 806 Model 463 with code XZ2, XZ3, XZ4, XZ5, XZ6
Reason for change	
Reason for block

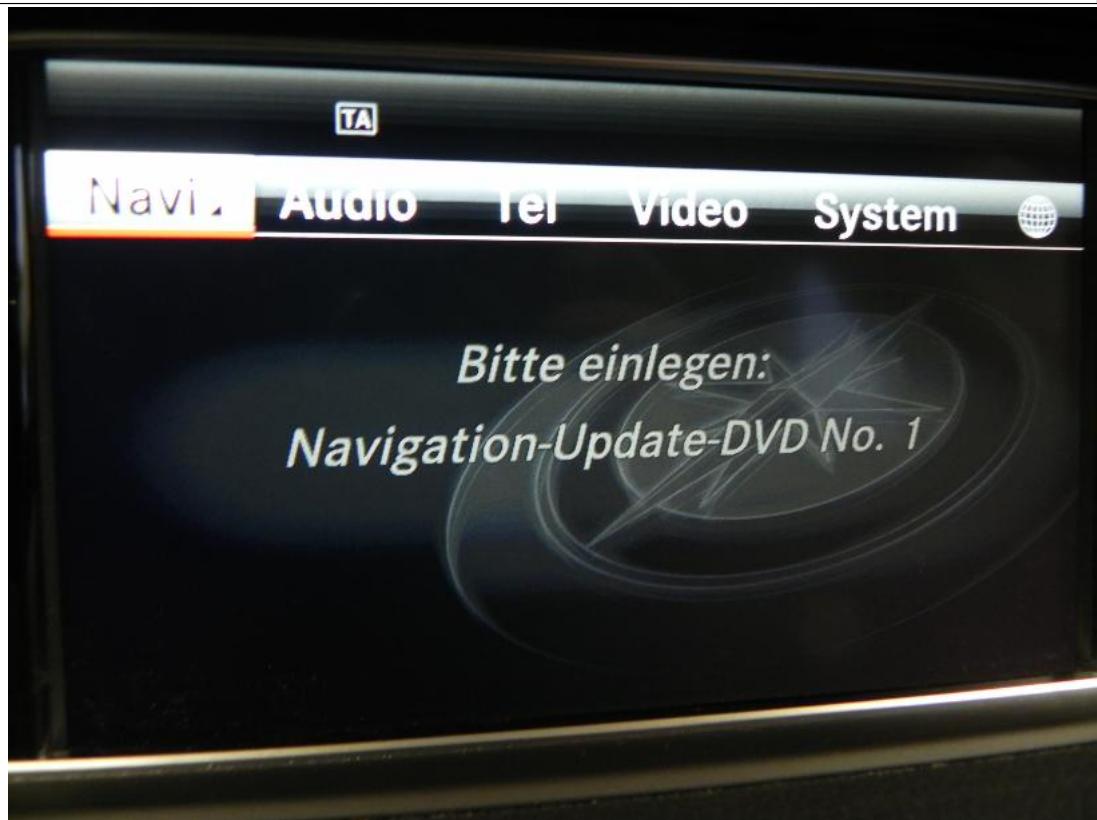
Bitte DV No1 einlegen.

"Please insert: Navigation Update DVD No. 1" (see Attachment)

Repeated attempts to update the map are unsuccessful.

Write error on the internal hard disk of the COMAND Online control unit (A40/3) due to unexpected voltage dips during the map update.

1. Delete the map data on the internal hard disk via XENTRY Diagnostics: Entry in the COMAND Online control unit (A40/3) -> "Special procedures" tab -> Navigation data (hard drive): Erase data (see Attachment).

Important: An external power supply must remain connected at all times while map data is being installed.

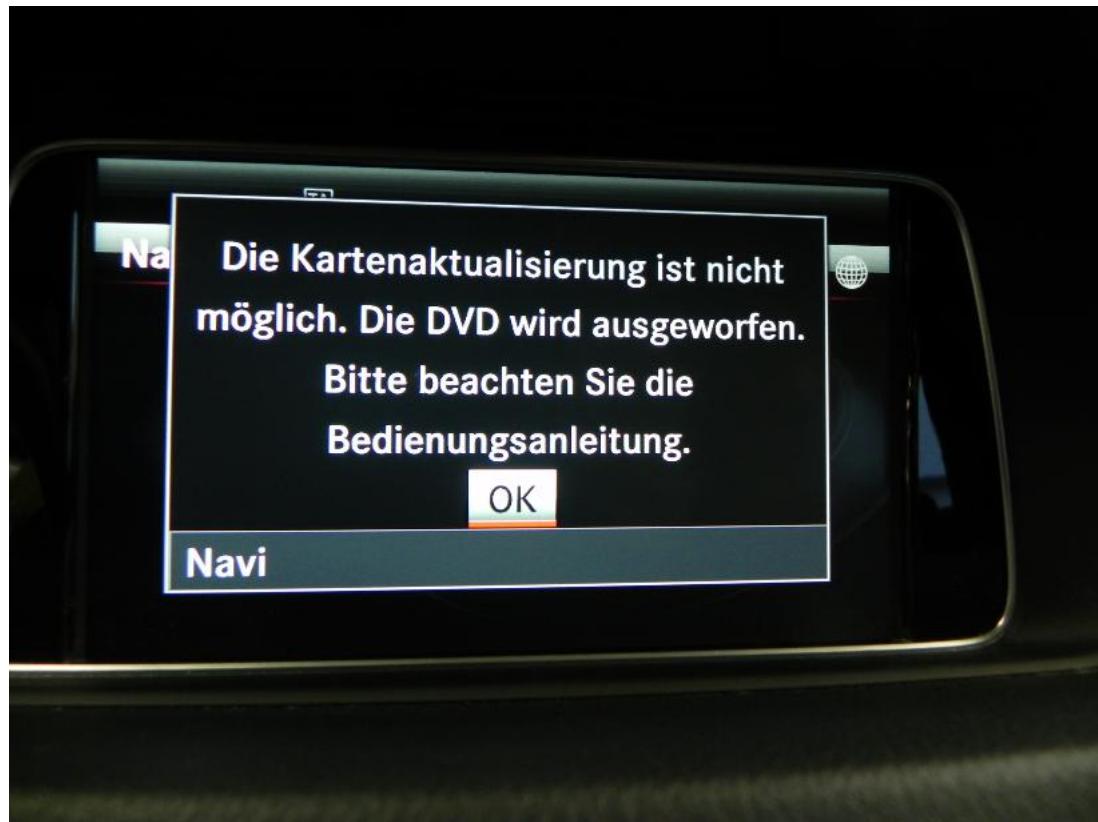
Kartenaktualisierung  
nicht möglich.JPG:

"Map update not possible. Ejecting DVD. Please refer to the operating instructions" (see Attachment)
