Automatic transmission oil loss in area of wiring harness and oil pan gasket

Topic number	LI27.00-N-048696
Version	3
Function group	27.00 General
Date	07-24-2017
Validity	Transmission 722.680/681/682/683/684/685 in model 639, 903, 904, 905, 906
Reason for change	Distribution revised
Reason for block

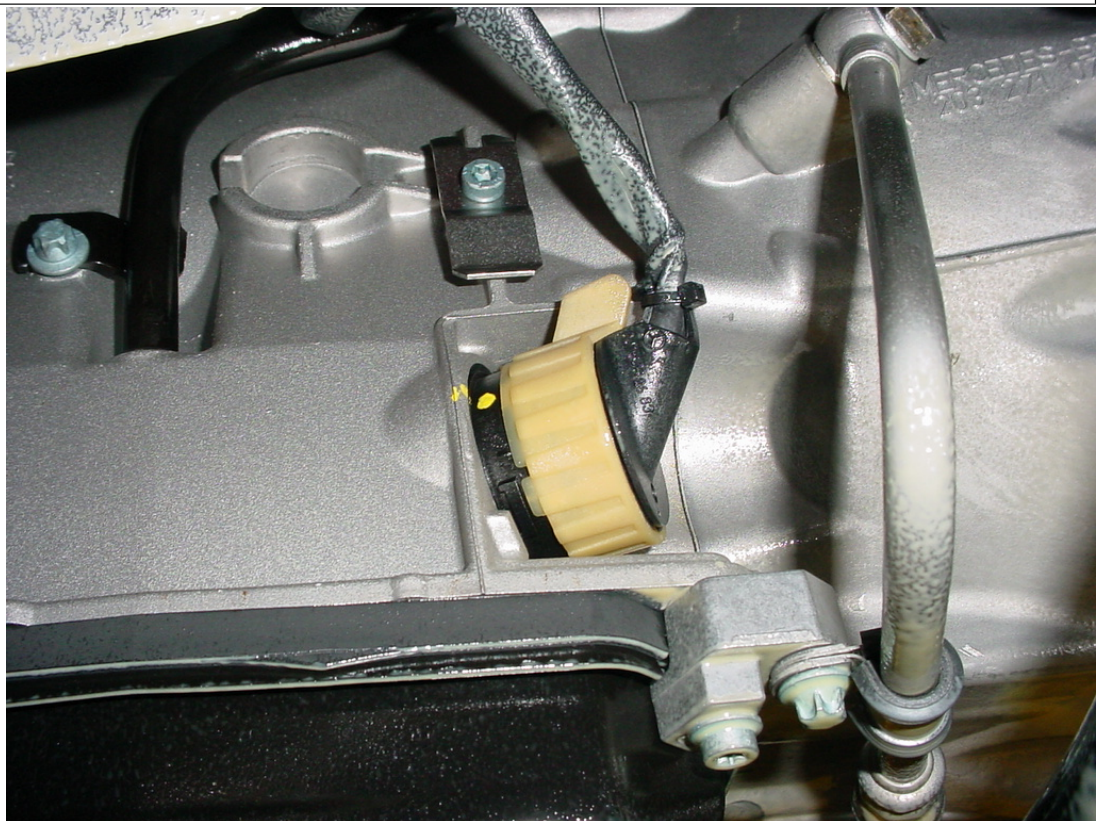
1.jpg:

reason to replace a wiring harness). The pictures in the attachment show examples of bad (Figure 2) and good (Figure 1) routing.

When connecting the wiring harness to the transmission, make sure that the wiring harness is routed free of tension. No tensile forces may be transferred to the plug by the wiring harness. Increase outer cable length if necessary (no
