TO: Mercedes-Benz Dealer Principals, General Managers, Sales Managers, Service Managers, Parts Managers, Service Directors	FROM: Thomas Brunner, Department Manager, Vehicle Compliance and Analysis, Engineering Services
RE: Service Campaign 2017030011 Various Models MY 2005 - 2014 Replace Driver-side and/or Passenger-side Airbag	DATE: March 17, 2017

Campaign No. 2017030011, March 2017

SUBJECT: **Models 171, 197, 203, 204, 207, and 212**
Model Years 2005 - 2013
Replace Driver-Side and (if applicable) Front Passenger Air Bag

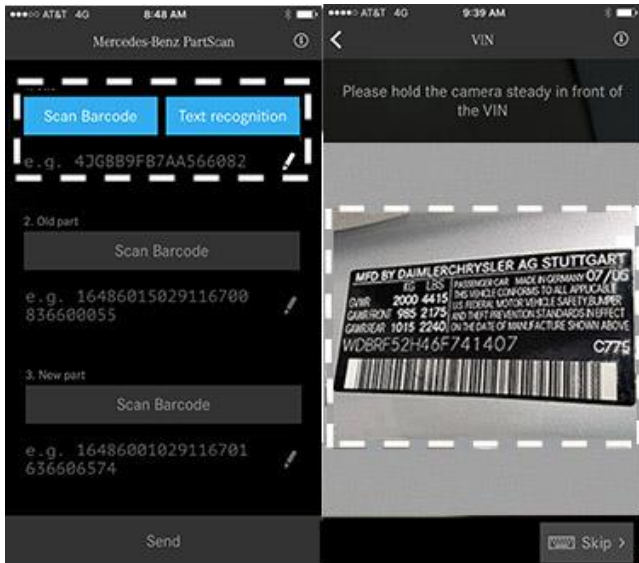
Figure 1

- Ensure that smart phone is held parallel to barcode label (Figure 1) when scanning VIN bar code.
- In the event the VIN barcode cannot be scanned when pressing the “Scan-Barcode” button or the vehicle does not have a VIN bar code; scan using the “Text recognition button and letter/number combination of the VIN (Figure 1).
- The VIN can also be entered manually if required.

2. Scan vehicle's VIN at left B-pillar using i-phone® or Android® smart phone.

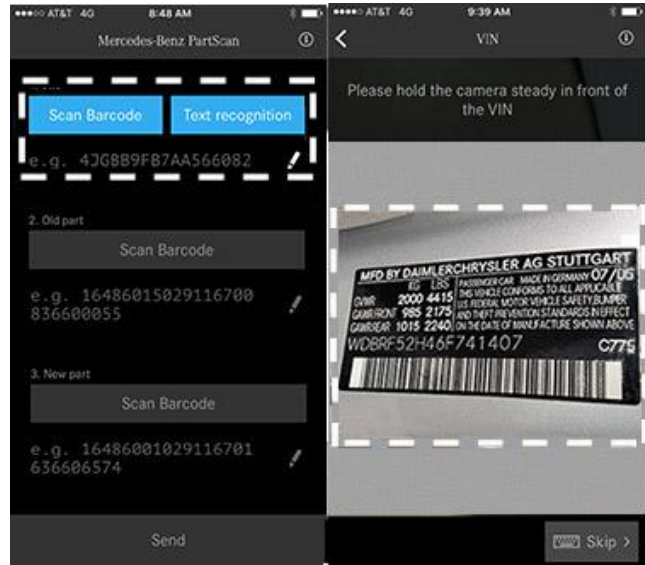
Figure 6

- Ensure that smart phone is held parallel to barcode label (Figure 6) when scanning VIN barcode.
- In the event the VIN barcode cannot be scanned when pressing the “Scan-Barcode” button or the vehicle does not have a VIN barcode; scan using the “Text recognition button and letter/number combination of the VIN (Figure 6).
- The VIN can also be entered manually if required.

1. Scan vehicle's VIN at left B-pillar using i-phone® or Android® smart phone.

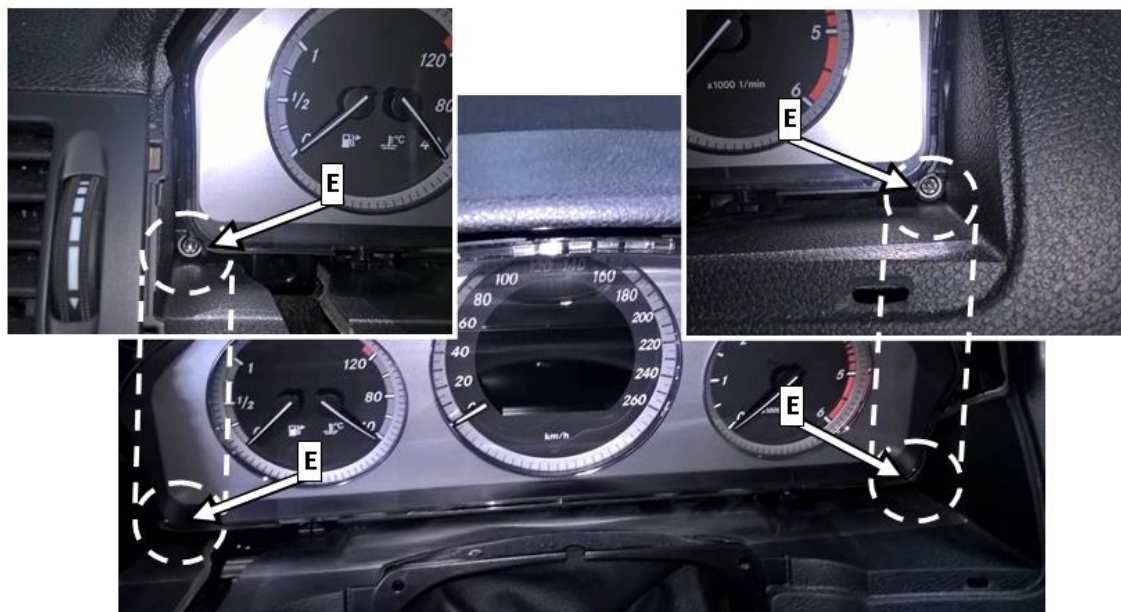
Figure 9

- These screws (E) are simultaneously fastening screws for the instrument panel.
- The upper two screws do not need to be loosened.

- Remove the two bottom instrument cluster mounting screws (E, Figure 9).
