Lever for seat height adjustment worn

Topic number	LI91.10-P-067199
Version	1
Function group	91.10 Front seats
Date	10-20-2017
Validity	Model designation 176.052, 117.352, 117.952, 156.952
Reason for change	Error in RP object number
Reason for block

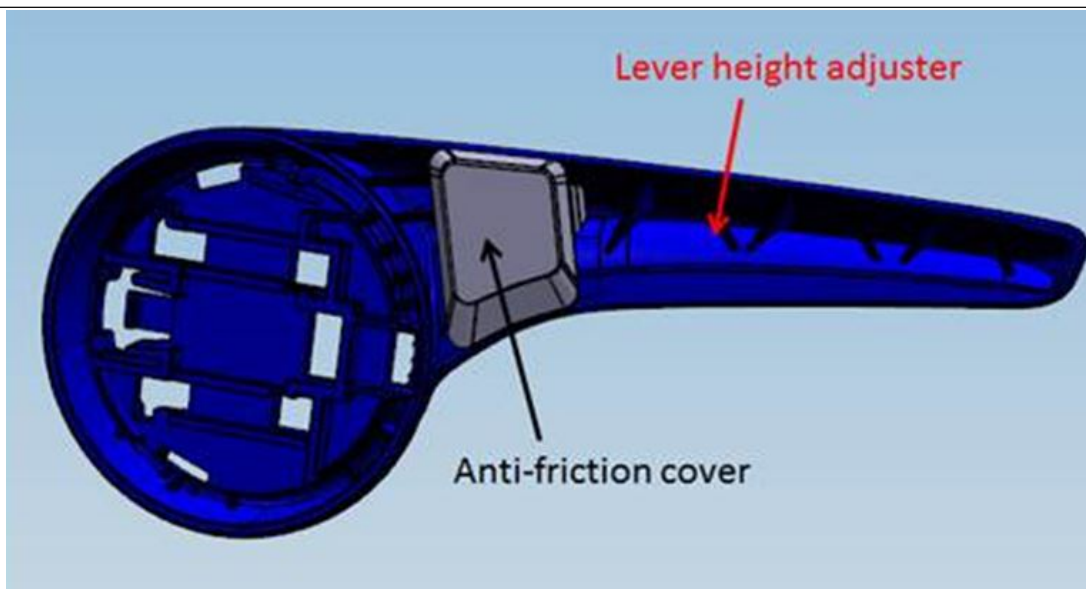
Hebel_Sitzhöhenverstellung.JPG:

The lever for the seat height adjustment can rub on the seat, so increased wear between the lever and the seat is possible.

Slider on lever for seat height adjustment to prevent friction is missing (see attachment).

Attachments	
File	Description
Hebel_Sitzhöhenverstellung.JPG	Lever with slider (anti-friction cover)

Replace lever for seat height adjustment.
