Vehicle does not start, battery discharged.

Topic number	LI54.10-P-066341
Version	4
Function group	54.10 Battery, power supply, voltage converter
Date	10-26-2017
Validity	BR231 and BR172
Reason for change	Remedy for Cause 1 available
Reason for block

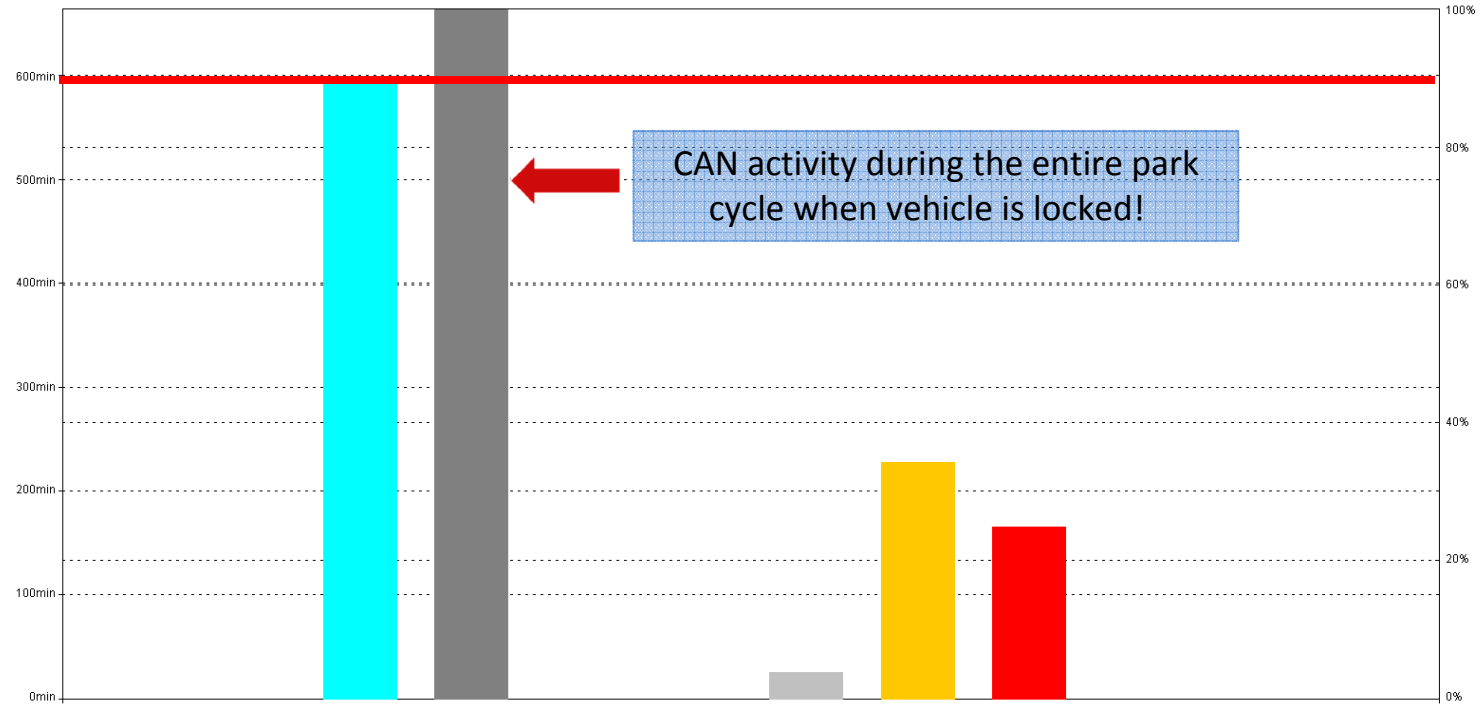
Standzyklus: 1238km - 03.06.2014 17:19:00

To be able to assess whether a bus keepawake event caused the battery discharge, it is necessary to examine the stationary cycles. A constantly active CAN is identified by the text "Interior CAN awake unusually long" (see attachment). If this text is not displayed, the battery discharge has a different cause.

Gesamtwegstrecke:	1238km
Standzeit vor Motorstart:	664min
Ladebilanz:	-40Ah
Ruhestromwert bei Klemme 30g EIN:	-26.0000kA
Ruhestromwert bei Klemme 30g AUS:	-42.0000kA

Auffälligkeiten
Innenraum-CAN-Bus ungewöhnlich lang WACH
Ladebilanz AUFFÄLLIG

Interior CAN bus is awake unusually long. Charging balance suspicious.

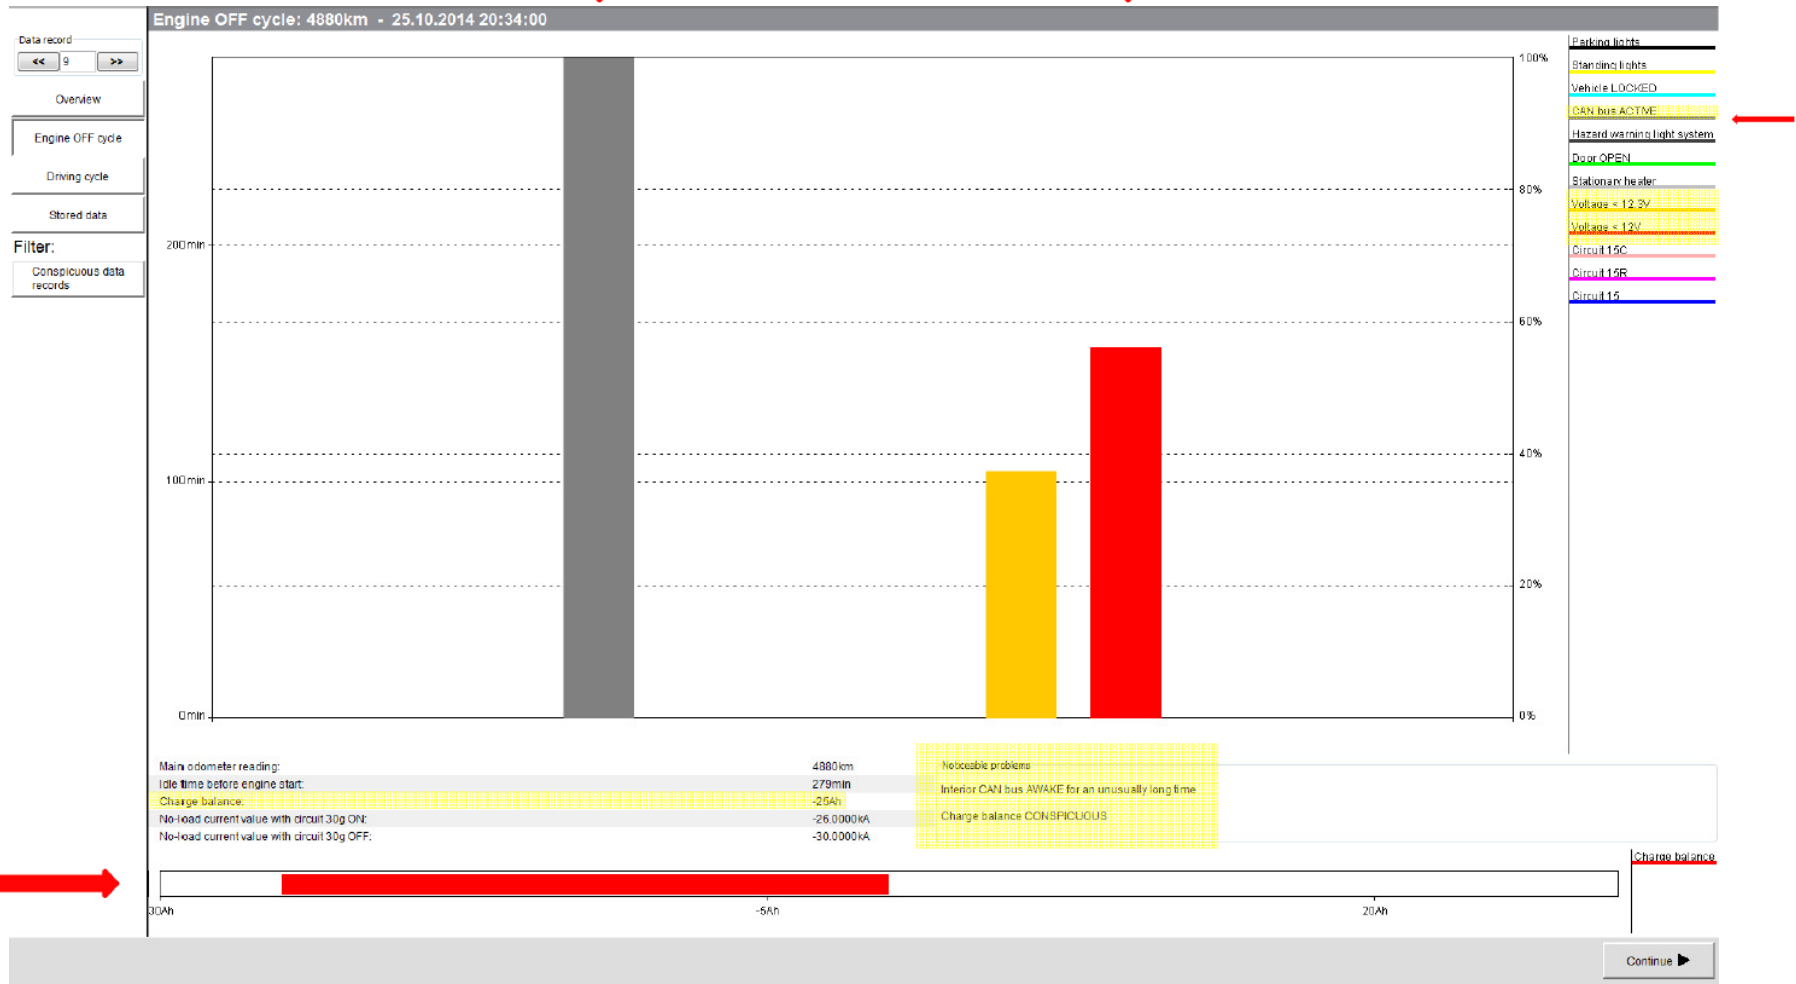
BODY-CAN keeps awake – technical issue
