Message in instrument cluster in yellow "Battery Symbol – Start Engine. See Owner's Manual"

Topic number	LI54.10-P-065969
Version	4
Function group	54.10 Battery, power supply, voltage converter
Date	10-27-2017
Validity	BR205/253 up to production date 12/2016 Only affects vehicles with Hyundai Mobis battery sensor.
Reason for change	Details of the situation added to avoid the unjustified replacement of Bosch battery sensors that are not affected by this fault profile.
Reason for block

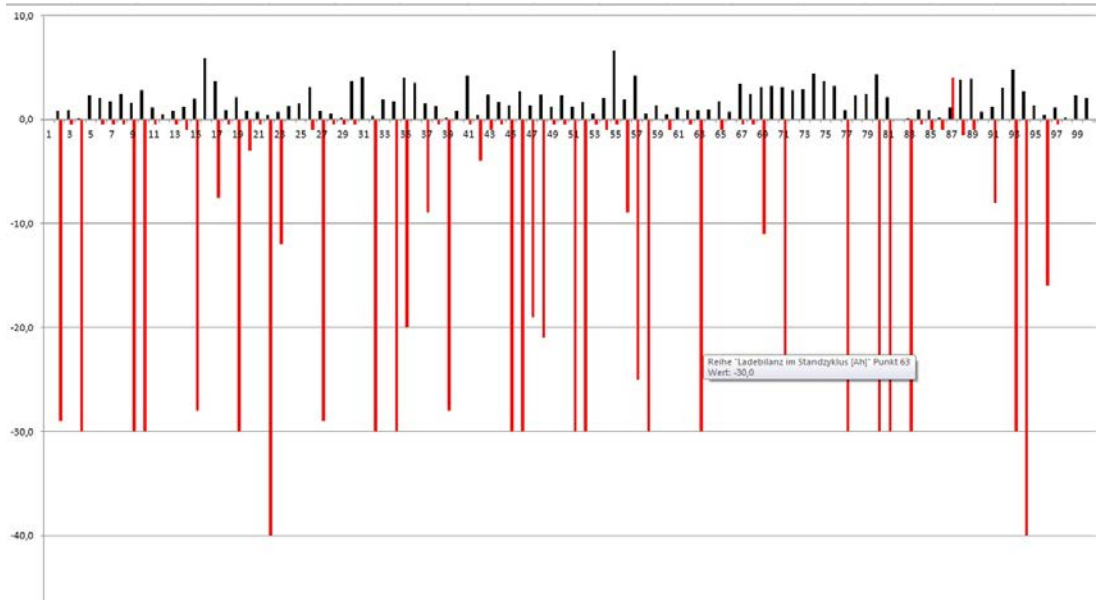
Bild1.jpg:

Attachments	
File	Description
Error in the calculation of the loading balance.pdf	Error in the calculation of the charge balance
Bild1.jpg	Drive and park cycle
