# Technical Bulletin

**93 19 01** February 18, 2019 **2051304** Supersedes Technical Bulletin 93-18-08 (V931808) dated October 11, 2018 to add model year 2019.

### High Voltage Battery - Charging Cable Cannot be Locked or Unlocked

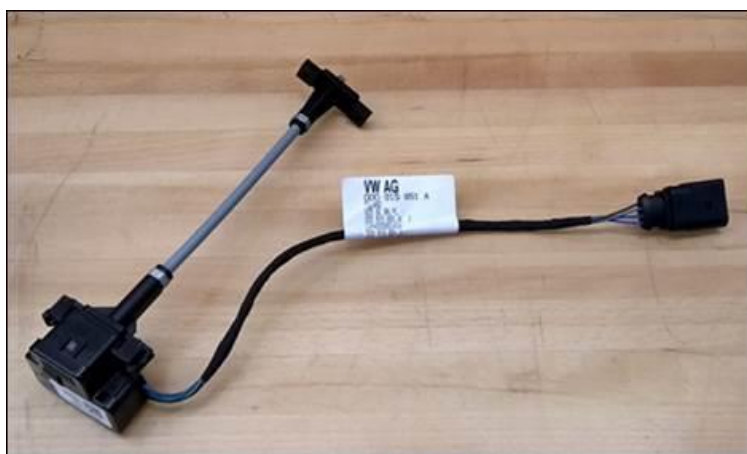
**Figure 1:** Repair kit actuator **-F498-** for North America (for use with NAR-version AC/DC Combo Socket).

- Replace the actuator **-F498-** (Figure 1) according to the repair manual and parts information table.
- Route repair wires and locate new connector as shown (Figure 2).

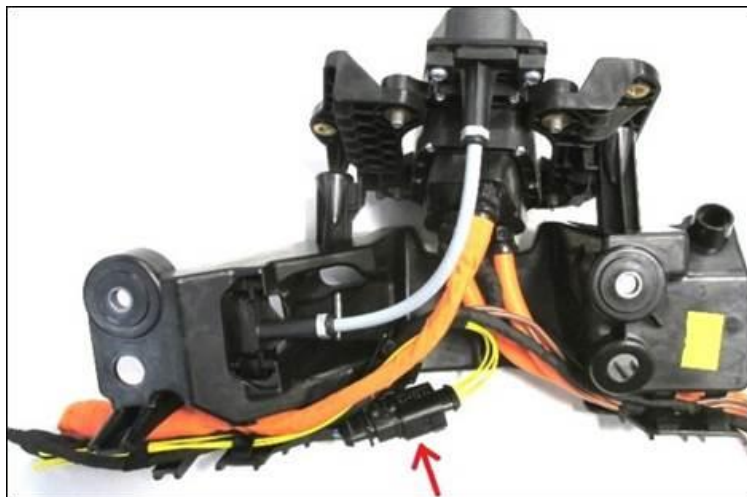
**Figure 2:** Finished location of new connector and correct wire routing. Repair wires (in yellow) are shown without tape for clarity only. The splices and wires must be properly wrapped in cloth tape part number N 10592002 for protection in actual repair.
