Technical Bulletin

94 19 01 February 18, 2019 2011521/14 Supersedes Technical Bulletin 94-17-01 (V941701) dated May 31, 2017 to include additional model and model year applicability.

Exterior Lights, Moisture Accumulation

Condensation and or water droplets visible on inside of exterior light lenses.

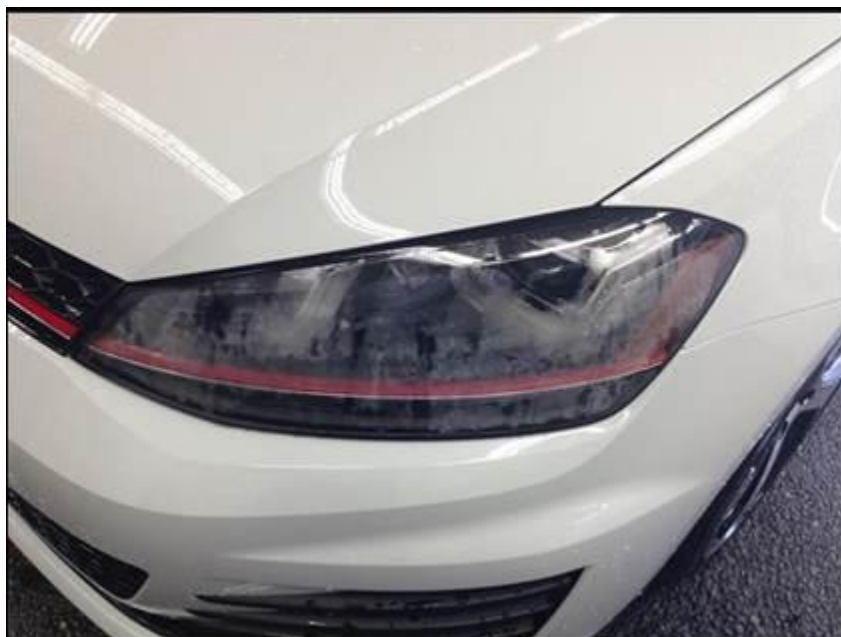
Figure 1

Exterior light assemblies (headlights, taillights, fog lights, turn signals) are vented and may collect moisture on their inner surfaces, depending on humidity and climatic conditions. The unfavorable condensation built up (Figure 1) visible to the customer is more common with modern exterior lights because of clear glass optics, however this condition will not have an impact on the functionality or durability of the component.

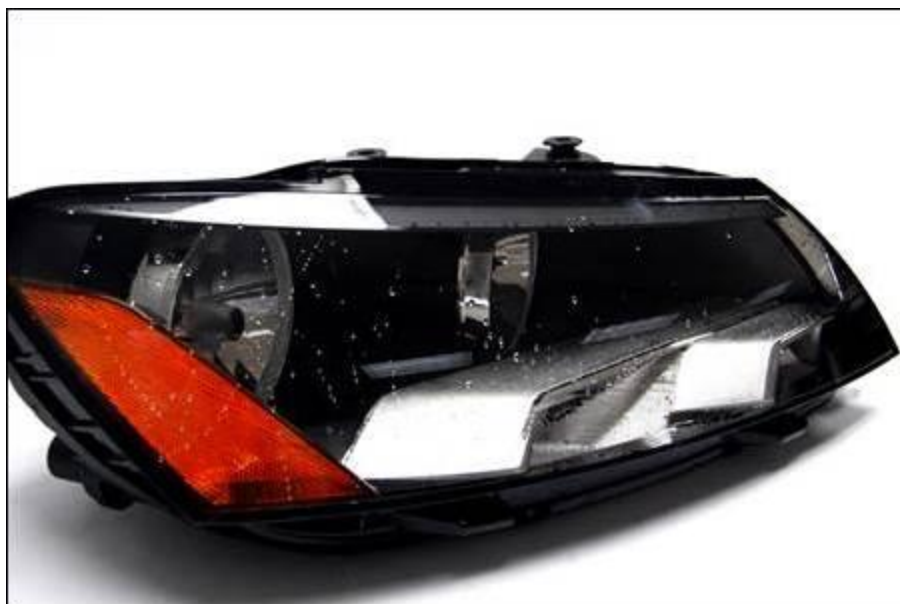
Figure 2

In cases where larger water droplets have formed on the inside of the lens or significant amount of water has collected at the bottom of a light assembly, Figure 2:

- Check that the housing covers (Figure 3), are properly installed. If the housing covers are not fully seated in place, use compressed air (less than 30 PSI) to blow out the lens and recheck for leaks.

- Check for leaking seals, cracks in lenses or assemblies.
